CONGRÈS
INTERNATIONAL
DE LA
CORROSION MARINE
ET DES
SALISSURES

8-12 Juin 1964
Cannes (FRANCE)

Corrosion et protection des ouvrages métalliques immergés.

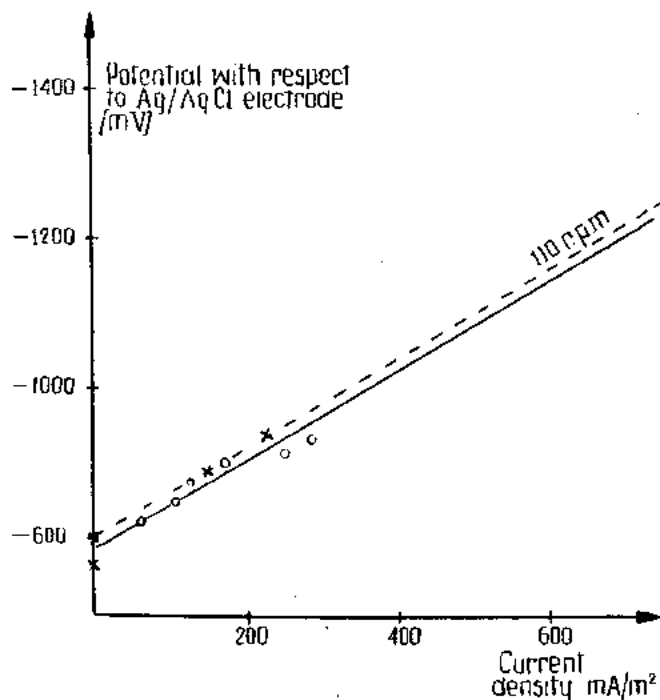
Fig. 4. — Relationship between cathodic current density and potential of the propeller.

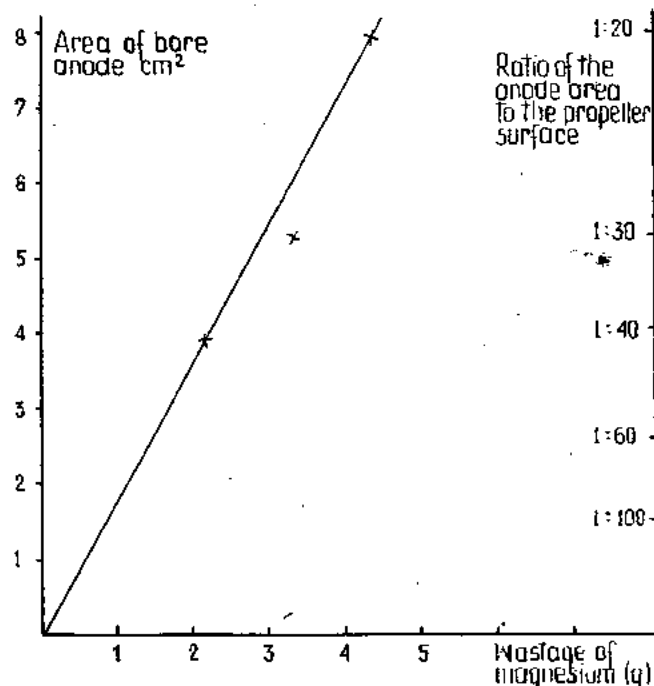
Fig. 5. — Relationship between magnitude of bare anode and wastage of magnesium. Measurements carried out with models of ship's propellers in the laboratorial cavitation plant.

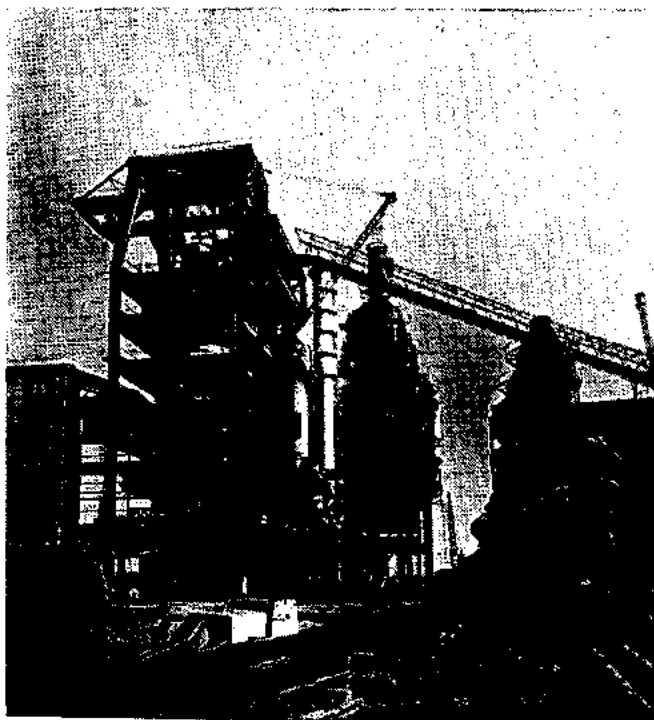
Photo 5. — Hauts-fourneaux d'Usinor à Dunkerque. Les blindages des hauts-fourneaux et les cheminées de cowpers de 75 mètres de hauteur sont métallisées à l'aluminium en 20/100^e d'épaisseur.

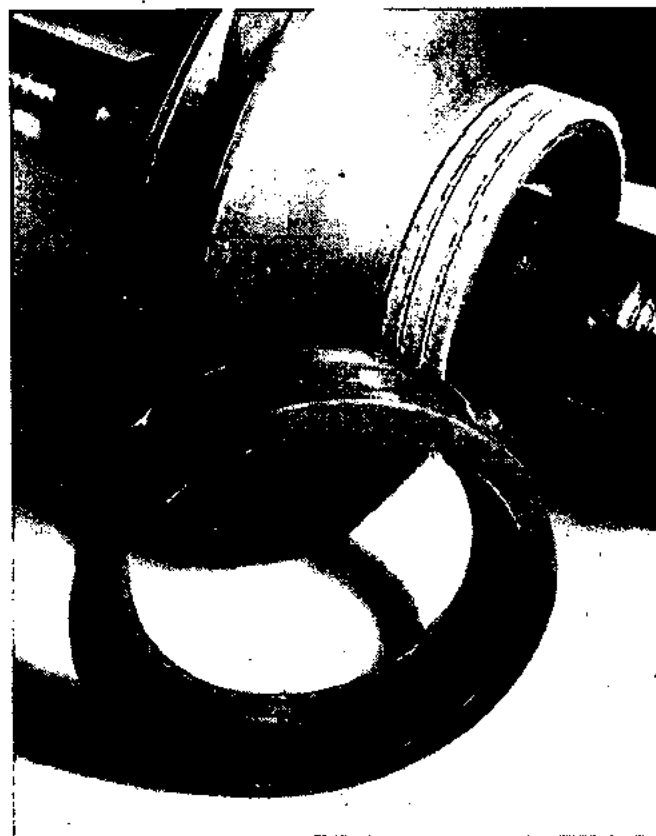
FIG. 28. — Bronze wear rings after two months in centrifugal sea water pump with bronze casing and "Monel" alloy 505 impeller and K-500 shaft.
