2<sup>ème</sup> CONGRÈS INTERNATIONAL DE LA CORROSION MARINE ET DES SALISSURES  
2<sup>nd</sup> INTERNATIONAL CONGRESS ON MARINE CORROSION AND FOULING  
2. INTERNATIONALER KONGRESS FÜR MEERWASSERKORROSION UND BEWUCHS  
2<sup>ον</sup> ΔΙΕΘΝΕΣ ΣΥΝΕΔΡΙΟΝ ΘΑΛΑΣΣΙΑΣ ΔΙΑΒΡΩΣΕΩΣ ΚΑΙ ΡΥΠΑΝΣΕΩΣ

20th to 24th September 1968 in Athens (GREECE)

Corrosion and protection of structure immersed in sea water or subjected to marine environments. Cathodic protection. Electrochemistry of sea water.

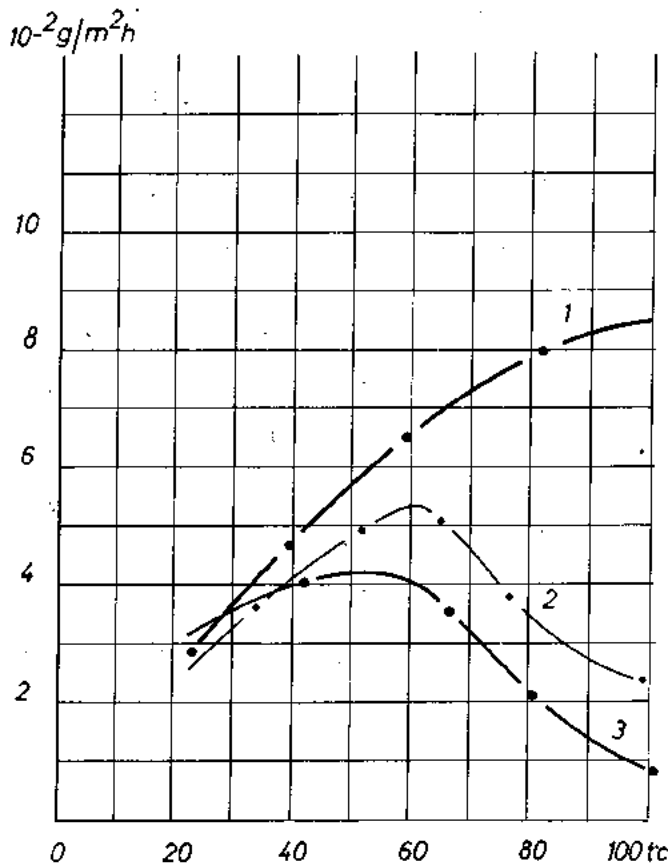
Fig. 3. — Effect of salts dissolved in sea water.  $MgSO_4$ , 3,305 g/l (c.1). M.A.B.R., 0,83 g/l (c.2),  $NaHCO_3$ , 0,202 g/l (c.3) on corrosion of steel 10 at different temperatures.

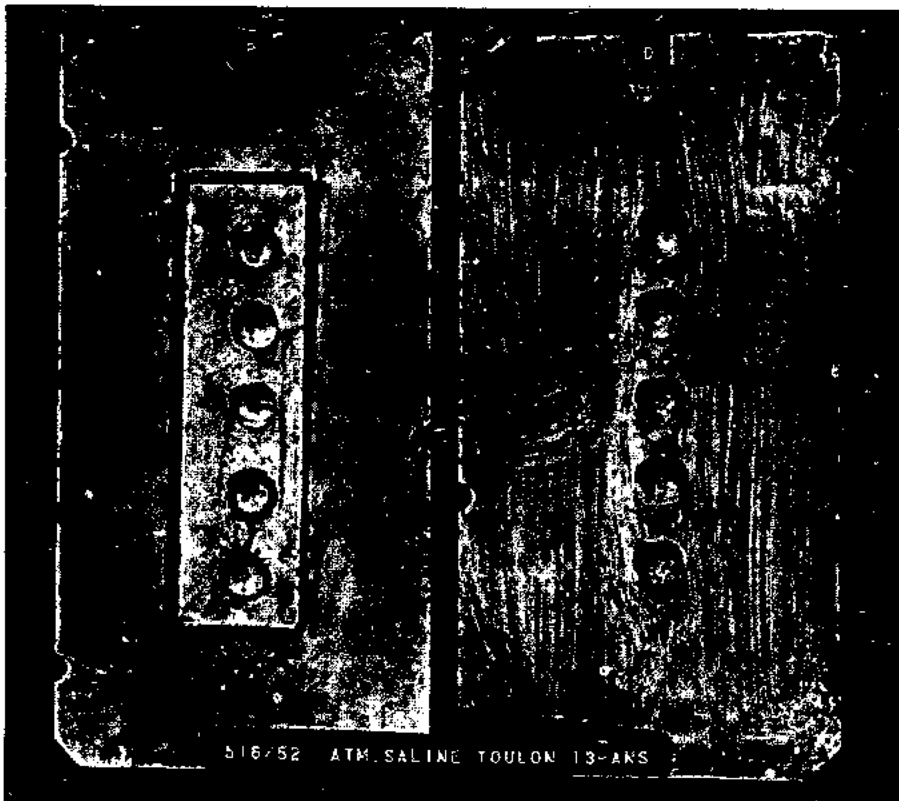
Fig. 8. — Tôles en A-G5 portant sur une face une bande en acier fixée par rivets en A-U4G. Protection du contact par ruban isolant et de l'ensemble par une peinture au chromate de zinc. Exposition à l'atmosphère saline à Toulon pendant 13 ans.

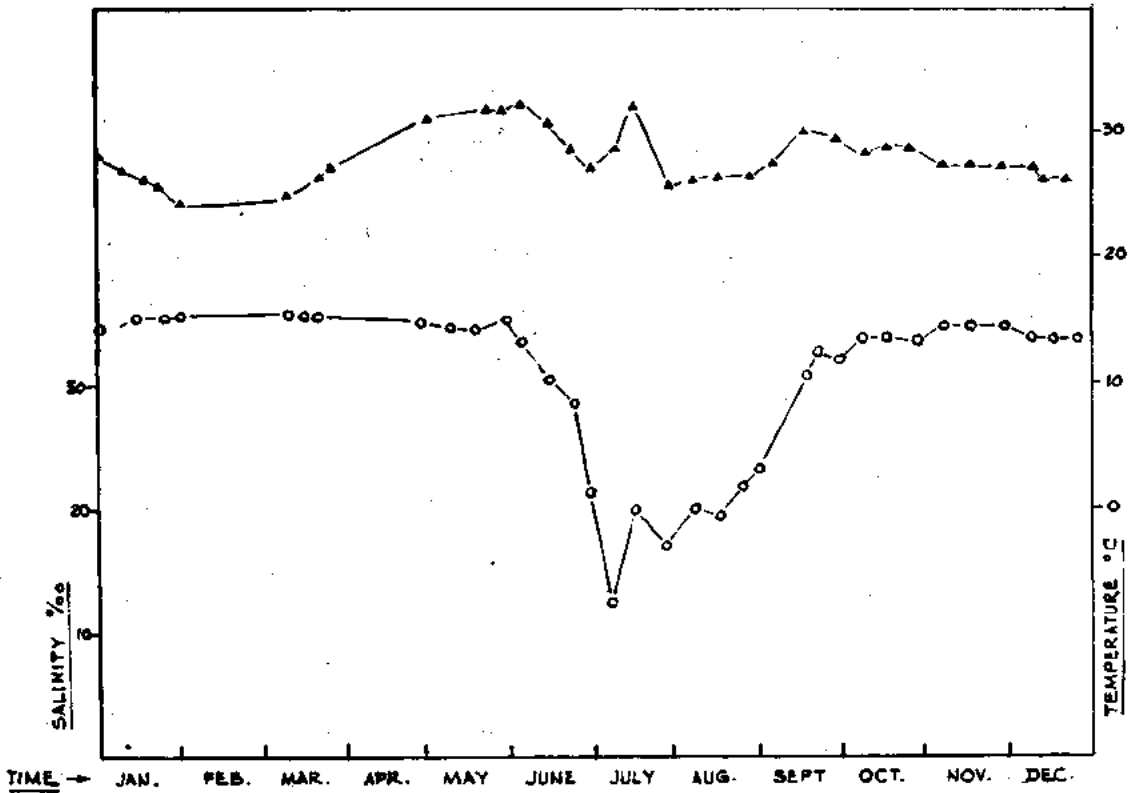
Fig. 2. — Salinity and temperature at Bombay harbour during 1960.

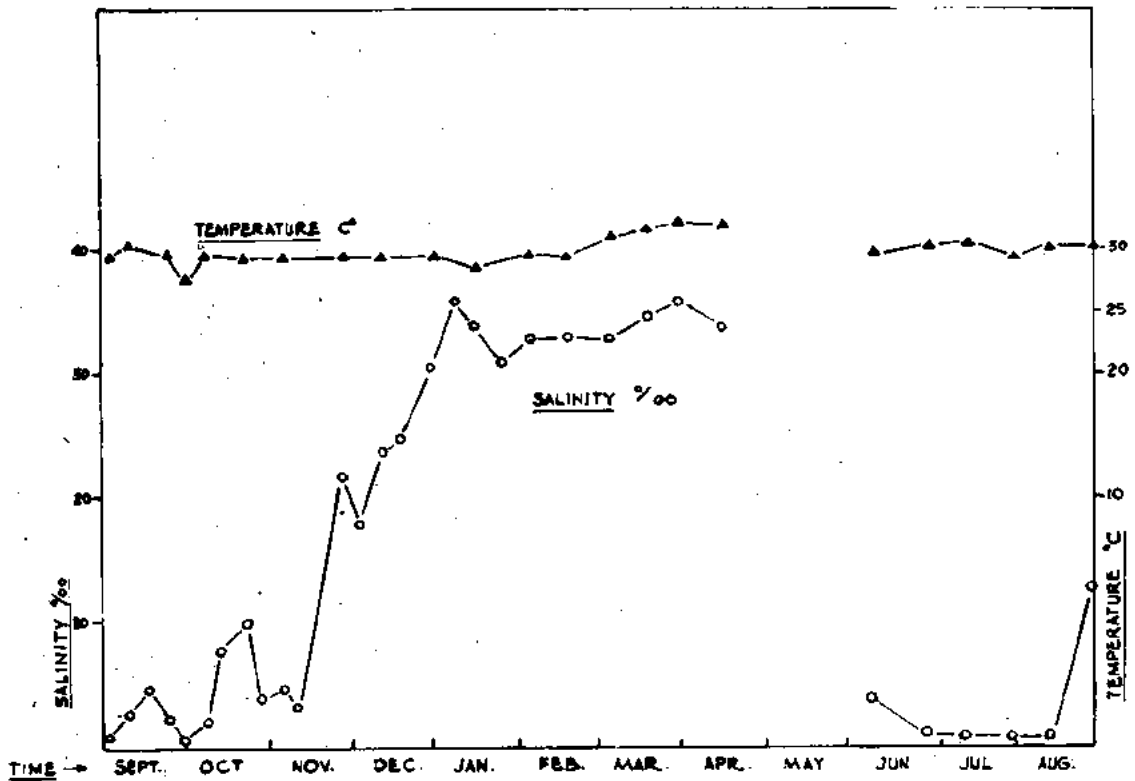
Fig. 3. — Salinity and temperature at Cochin harbour during Sept. 1959 to Aug. 1960.

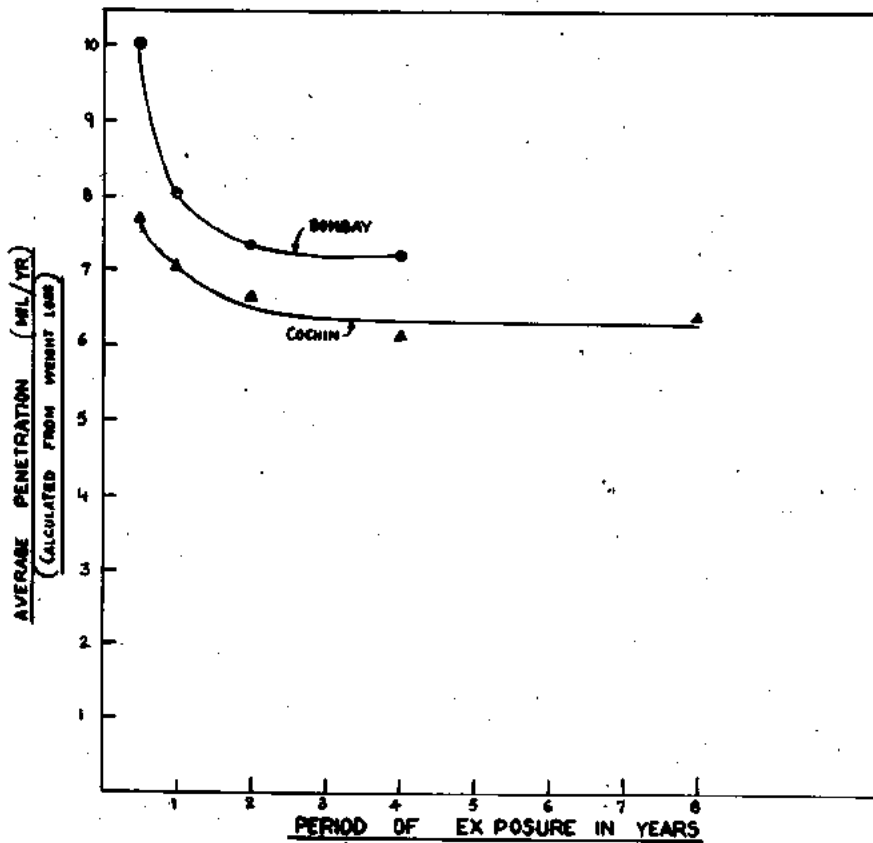
Fig. 8 CORROSION RATE (MILS/YR) OF MILD STEEL IN BOMBAY AND COCHIN HARBOURS

It will be observed from the Tables II to V and Figs. 8 and 14 that corrosion of mild steel under immersed conditions in seawater is more severe due to pitting than general wastage expressed by average penetration from loss in weight measurements. To illustrate, under immersed condition for a period of 2 years, mild steel suffers 7.8 and 6.2 times more penetration by pitting at Bombay and Cochin harbour than indicated by the corrosion rate (mil/yr) results. Pitting behaviour of mild steel, should therefore be taken into consideration during design and estimation of life of underwater structures rather than corrosion rate data. Pitting characteristics of mild steel in the 2 harbours is more severe than similar values reported for the Panama Canal Zone<sup>3, 4</sup>. Pitting rate of mild steel is

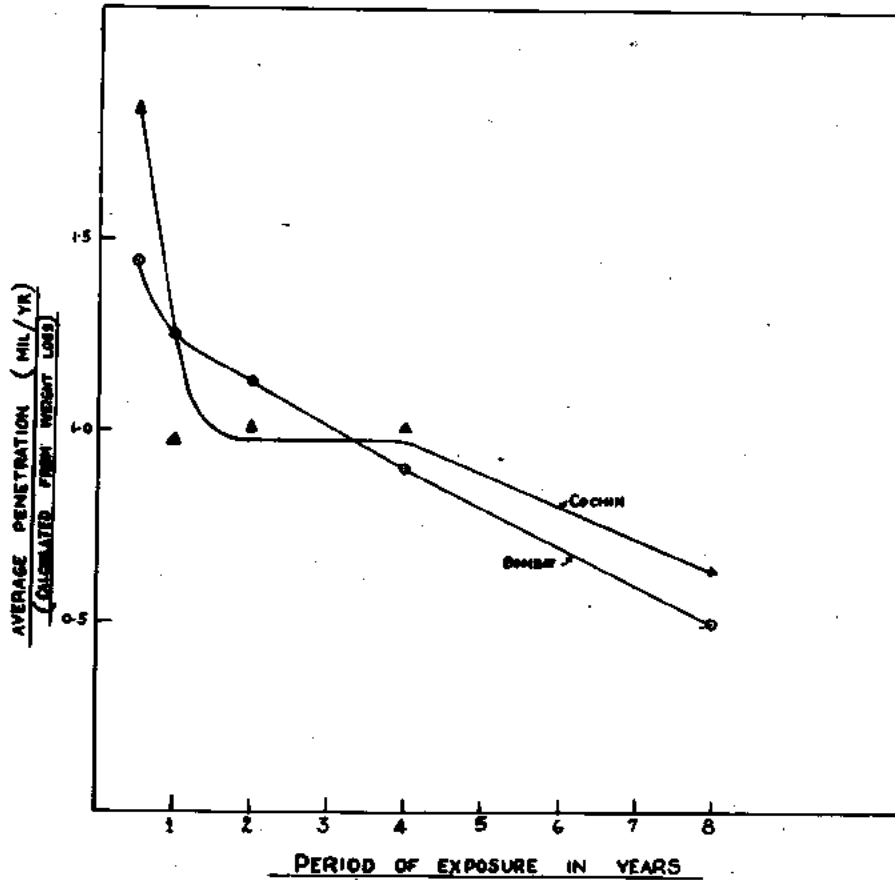
Fig. 9. — Corrosion rate (mil/yr) of copper in Bombay and Cochin harbours.

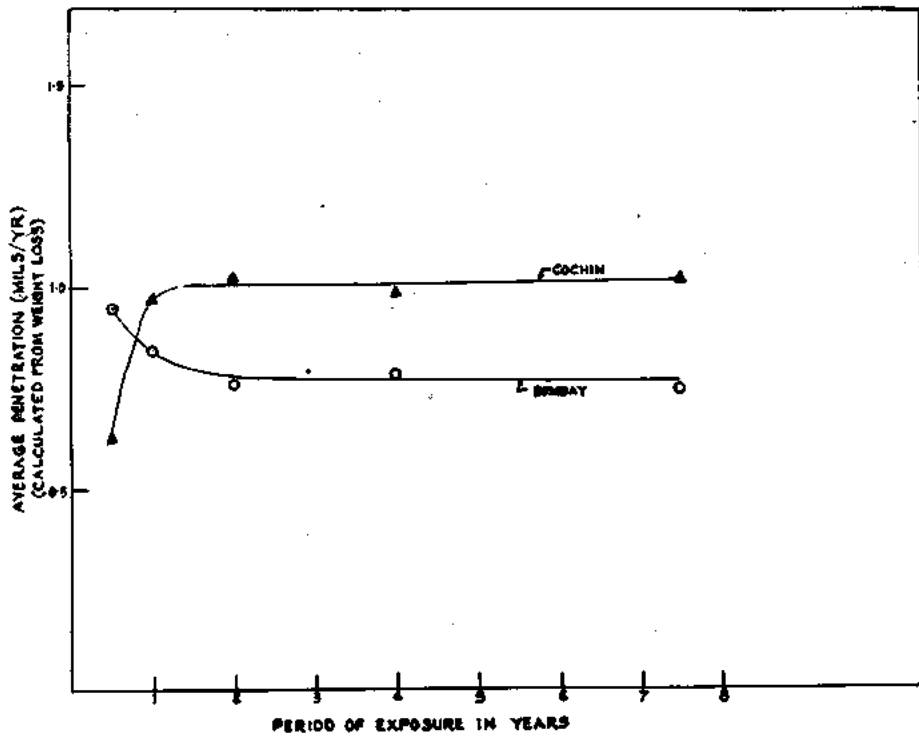
Fig. 10. — Corrosion rate (mils/yr) of naval brass in Bombay and Cochin harbours.

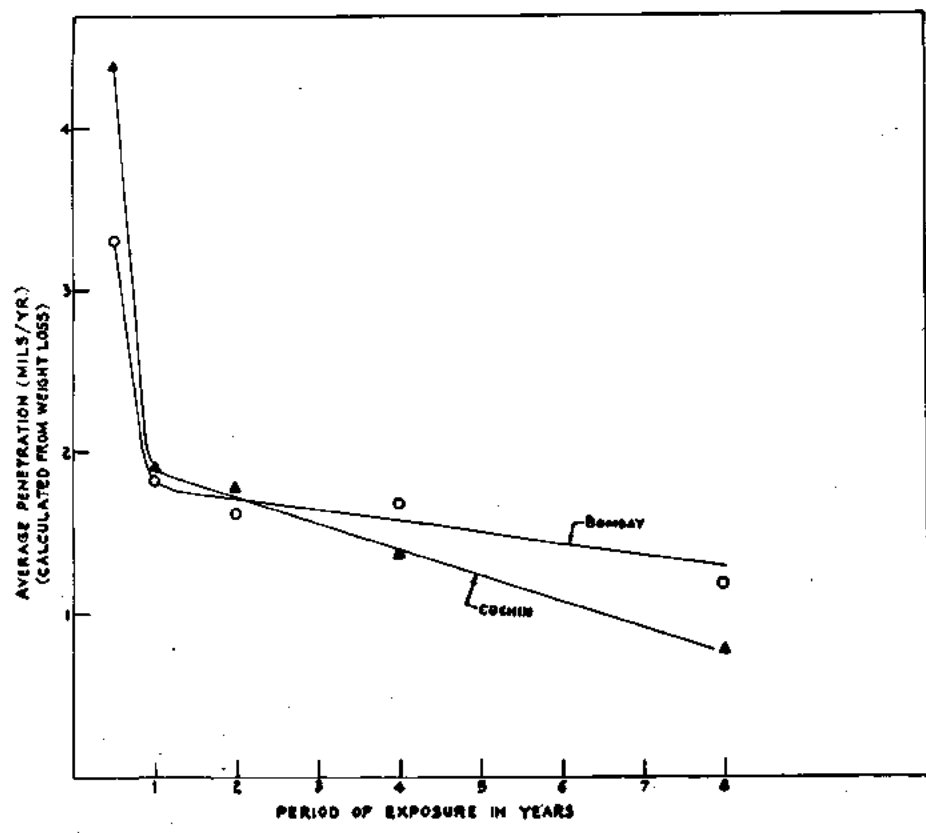
Fig. 11. — Corrosion rate (mils/yr) of zinc in Bombay and Cochin harbours.

Corrosion rate of zinc (Fig. 11) decreases with immersion

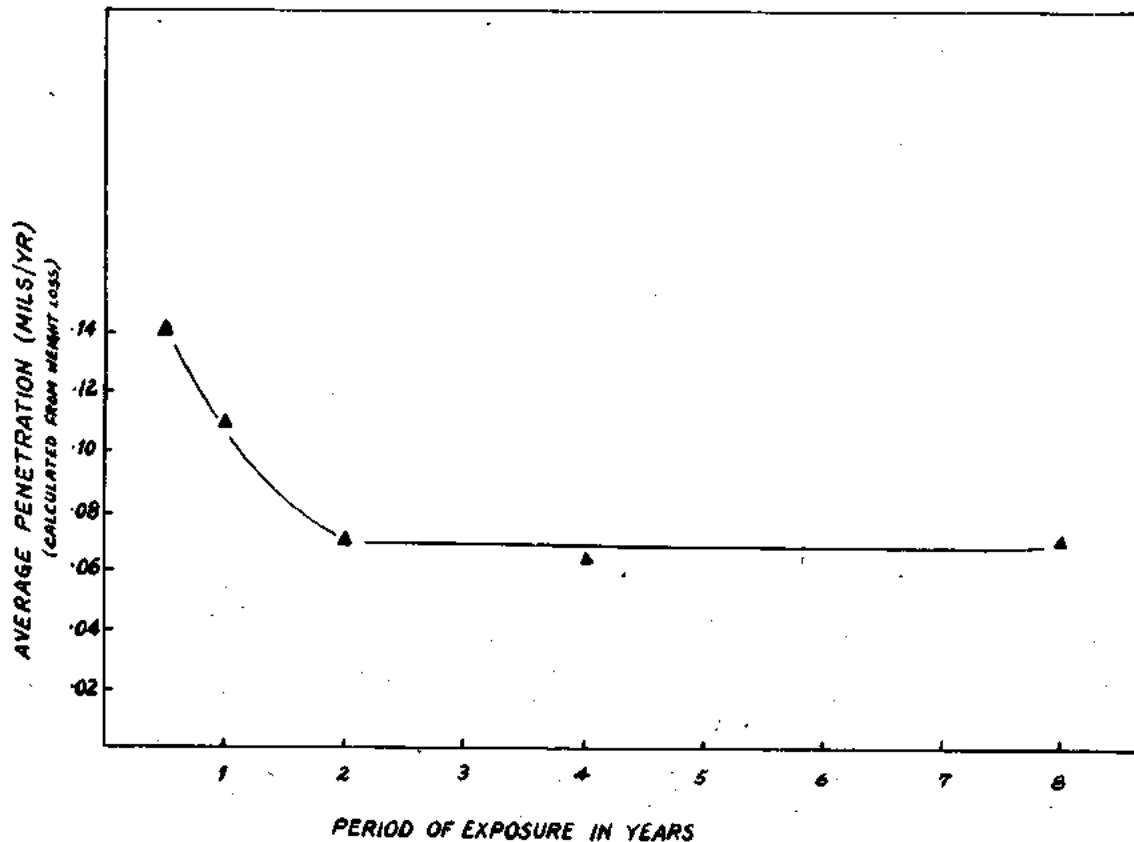
Fig. 12. — Corrosion rate (mils/yr) of aluminium in Cochin harbour.

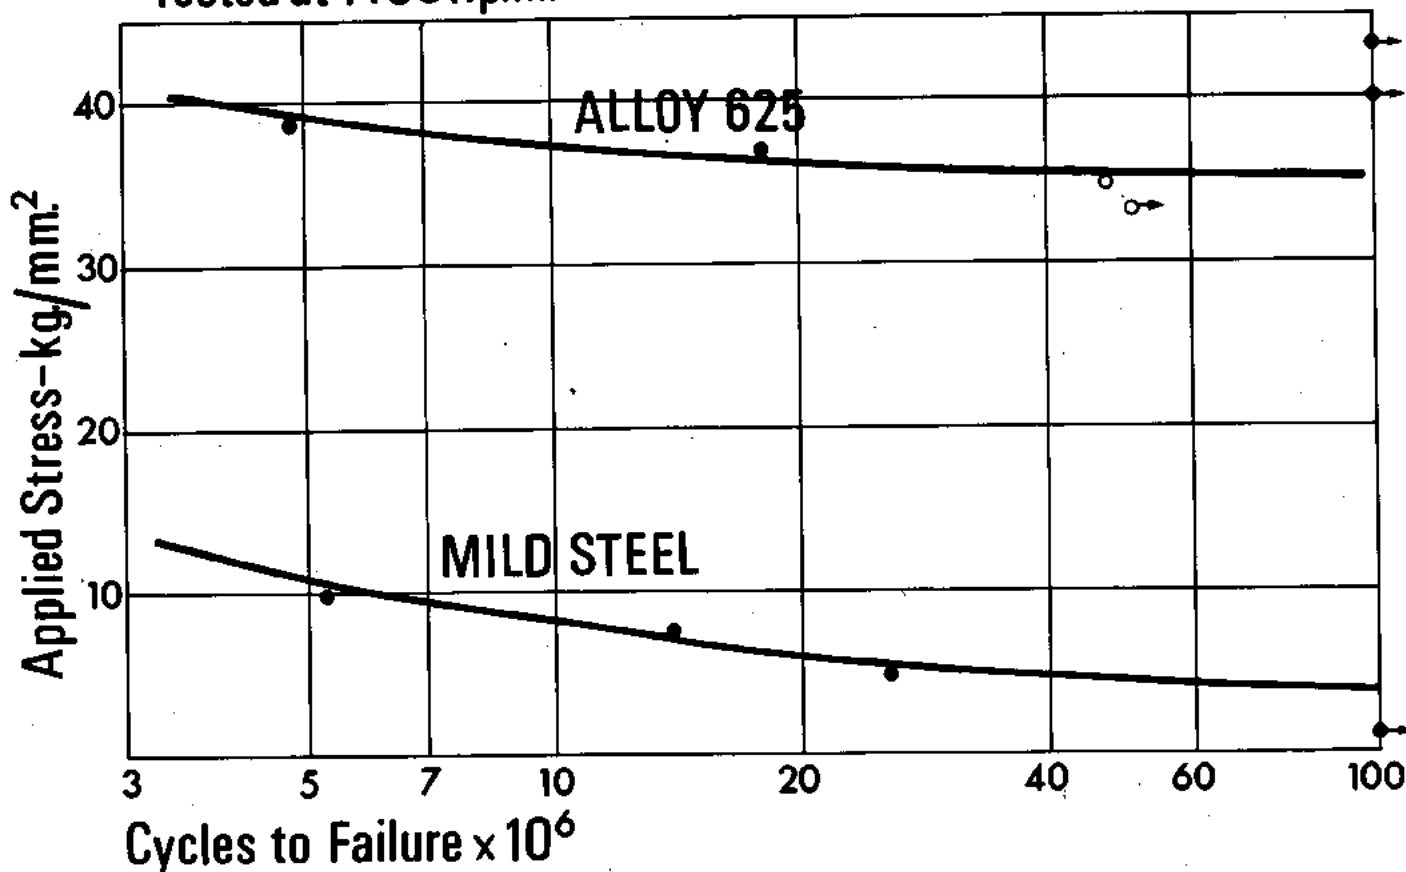
Fig 3 Corrosion-fatigue curves for Alloy 625 and Mild Steel in Sea Water

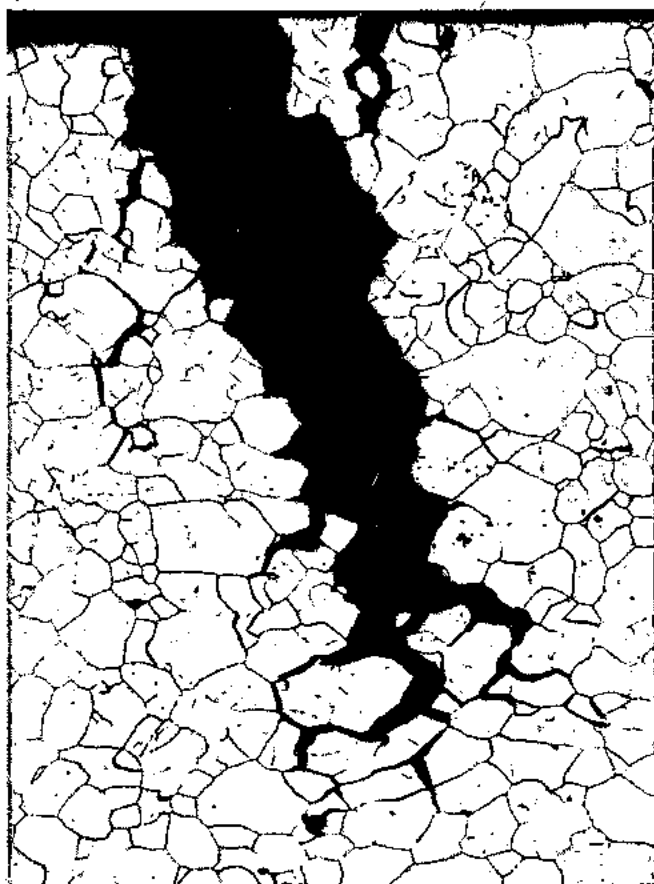
Bild 19. — Stahl X 40 MnCrN 19 C (%) Mn (%) Cr (%) N (%)  
30 min 1100°C/Wasser + 3 h 700°C/Luft  
Rissverlauf interkristallin  $V = 100$

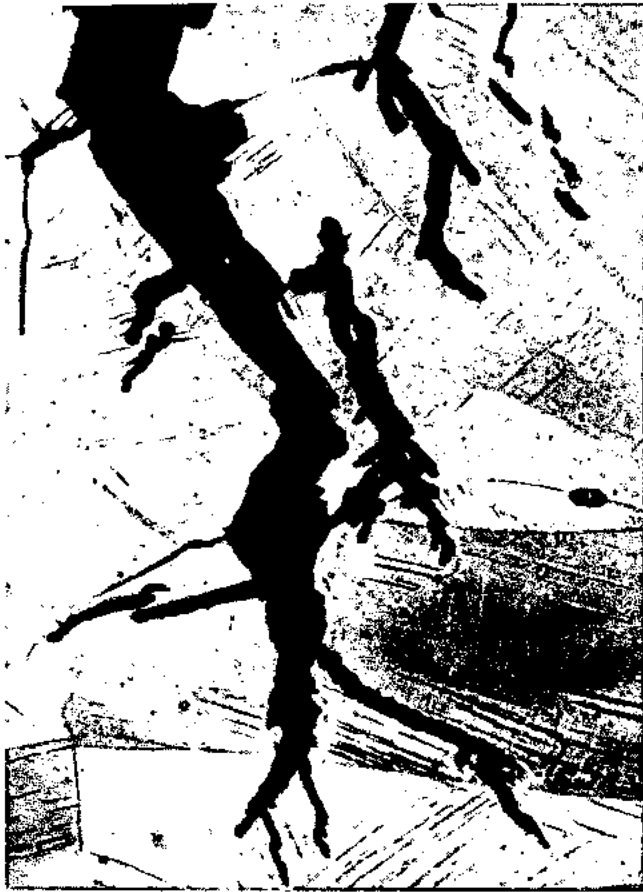
Bild 20. — Stahl x40 MnCrN 19 C (%) Mn (%) Cr (%) N (%)  
 0,41 18,8 4,5 0,12  
 30 min 1100°C/Wasser  
 Rissverlauf transkristallin V = 500

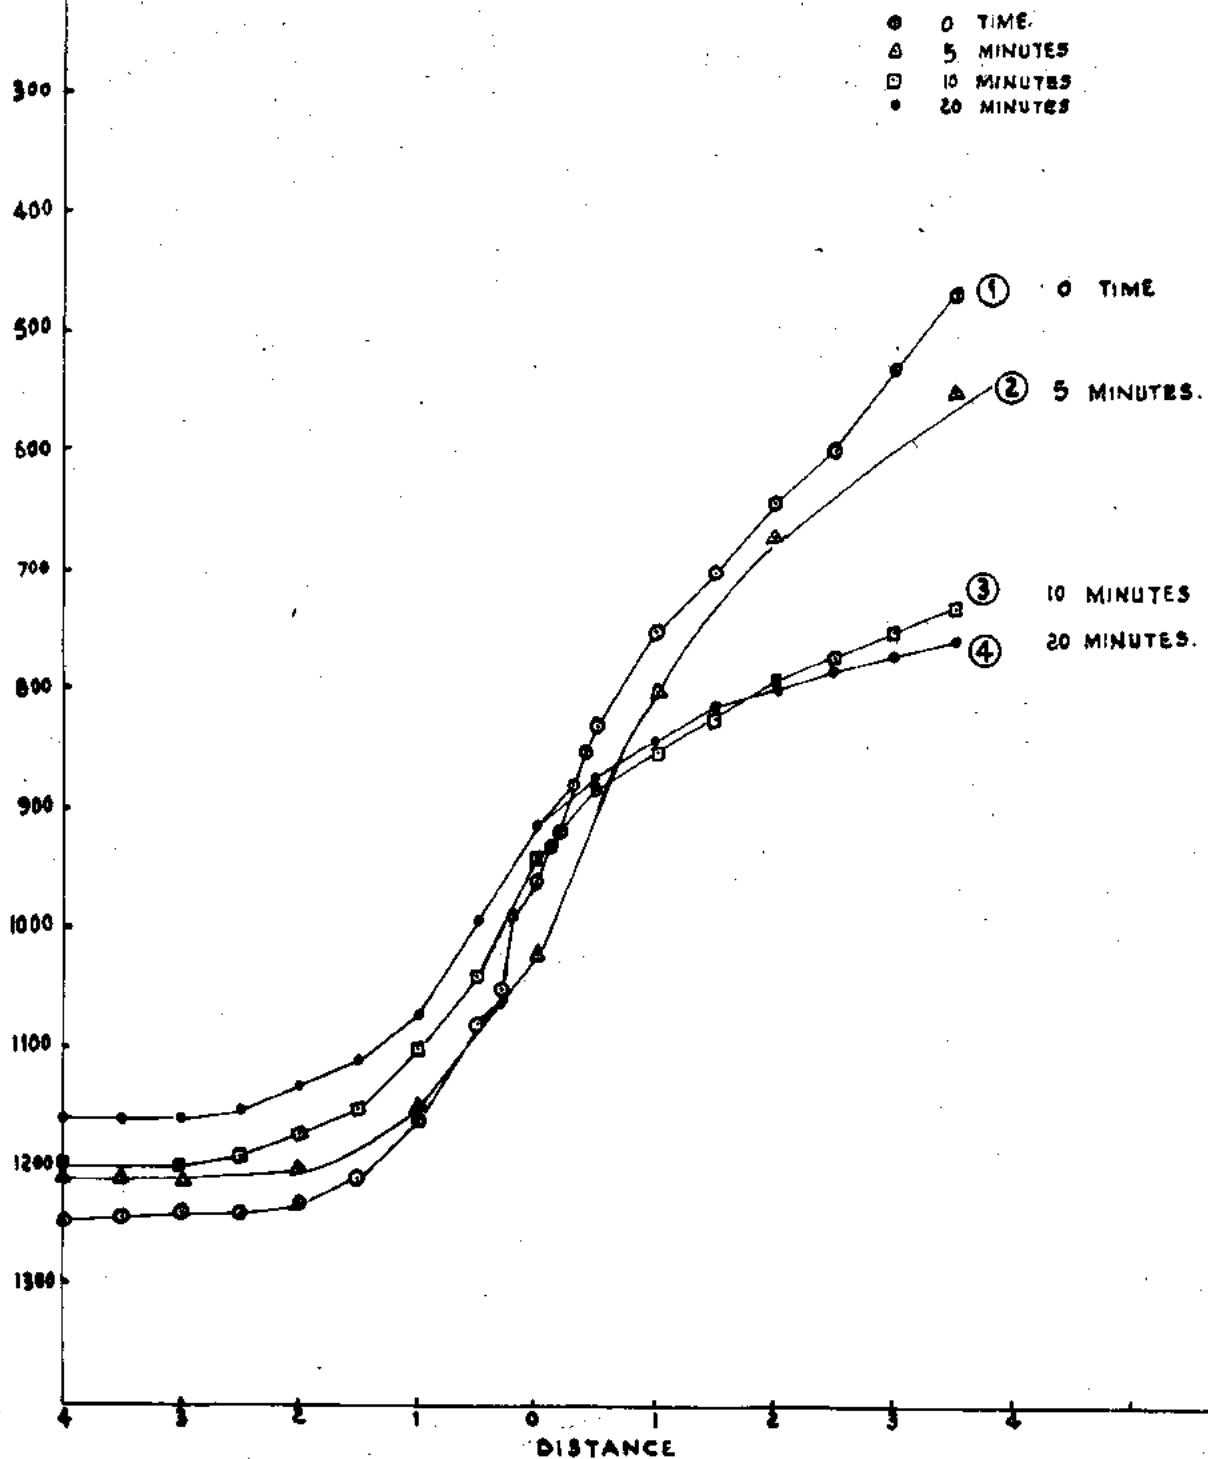
FIG. 5. CHANGE IN ELECTRODE POTENTIAL OVER A PARTIALLY PAINTED SURFACE IN SEA WATER.

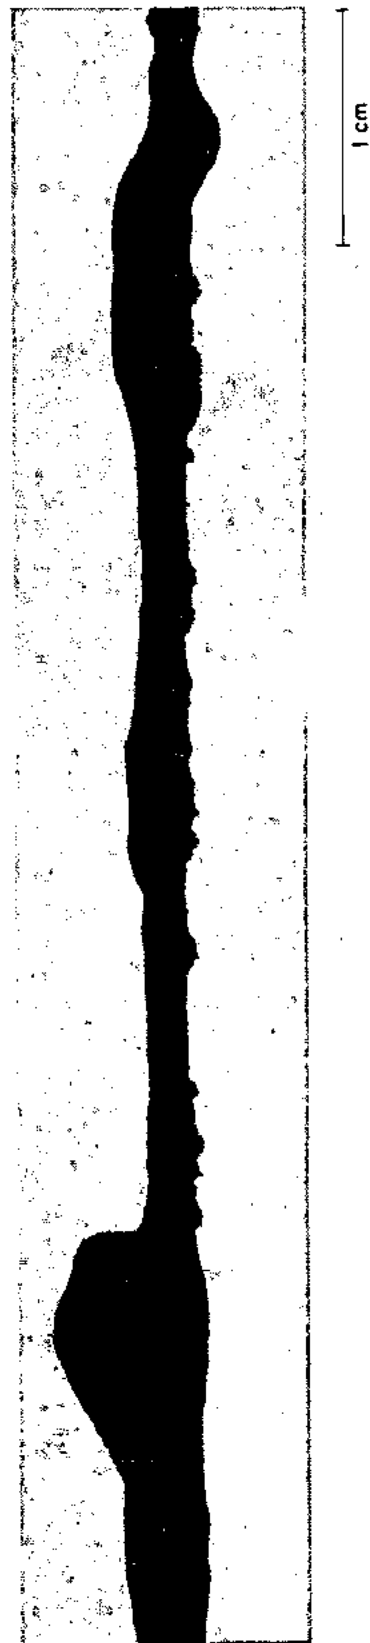
Fig. 3. Waxy-sludge-covered steel wire after exposure in sea-water.

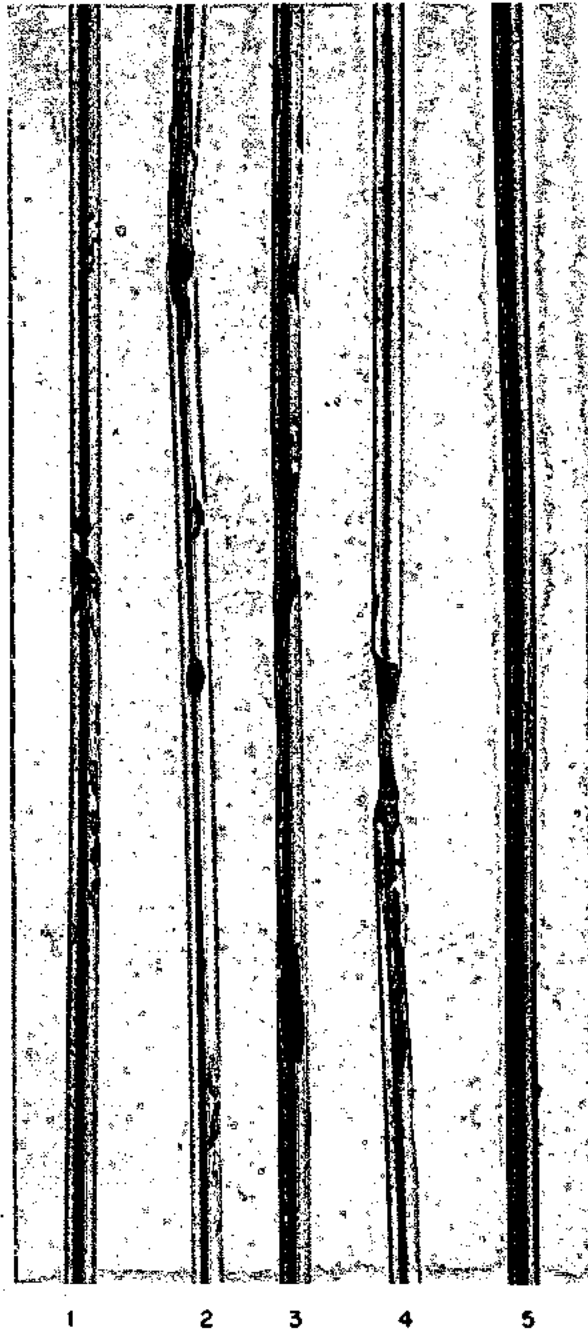
Fig. 4. Waxy-sludge-covered steel wires after exposure in sea-water.

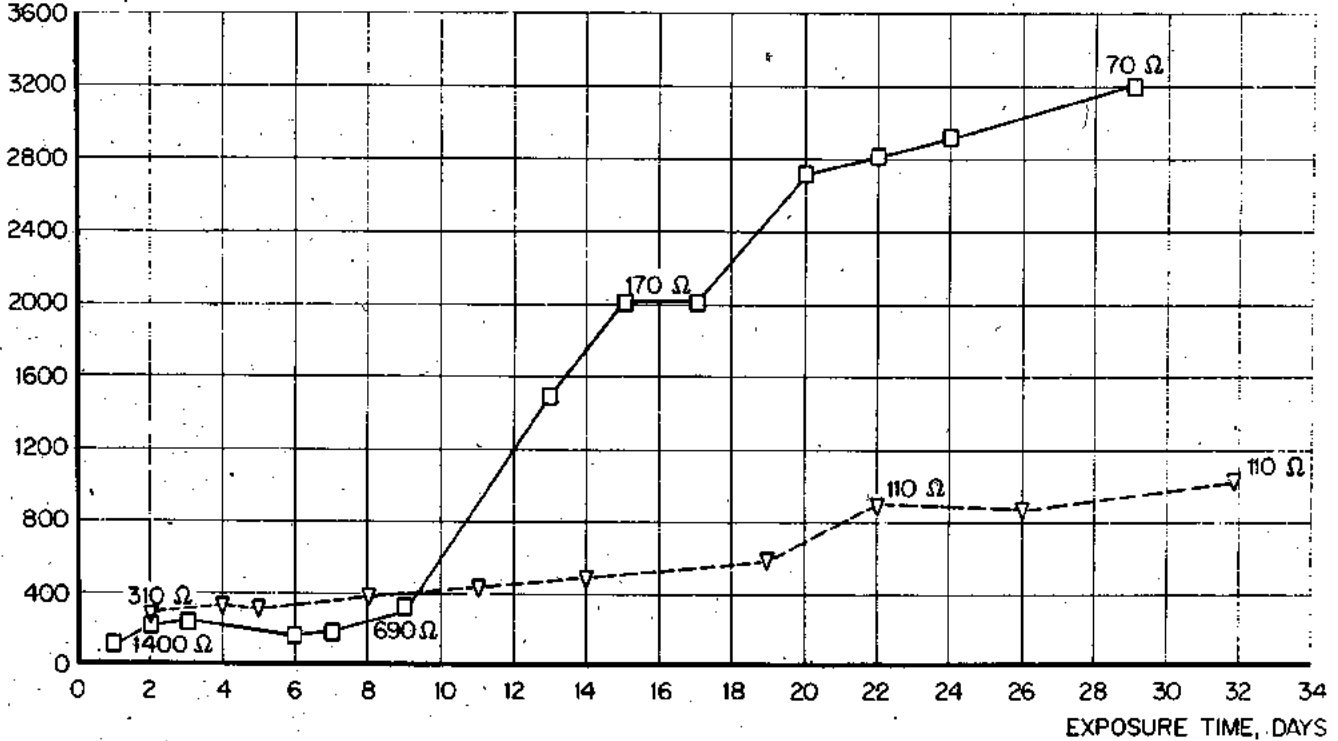
Fig. 6. Typical current-time and potential-time relationships for coupled waxy-sludge-covered steel/steel in aerated sea-water.

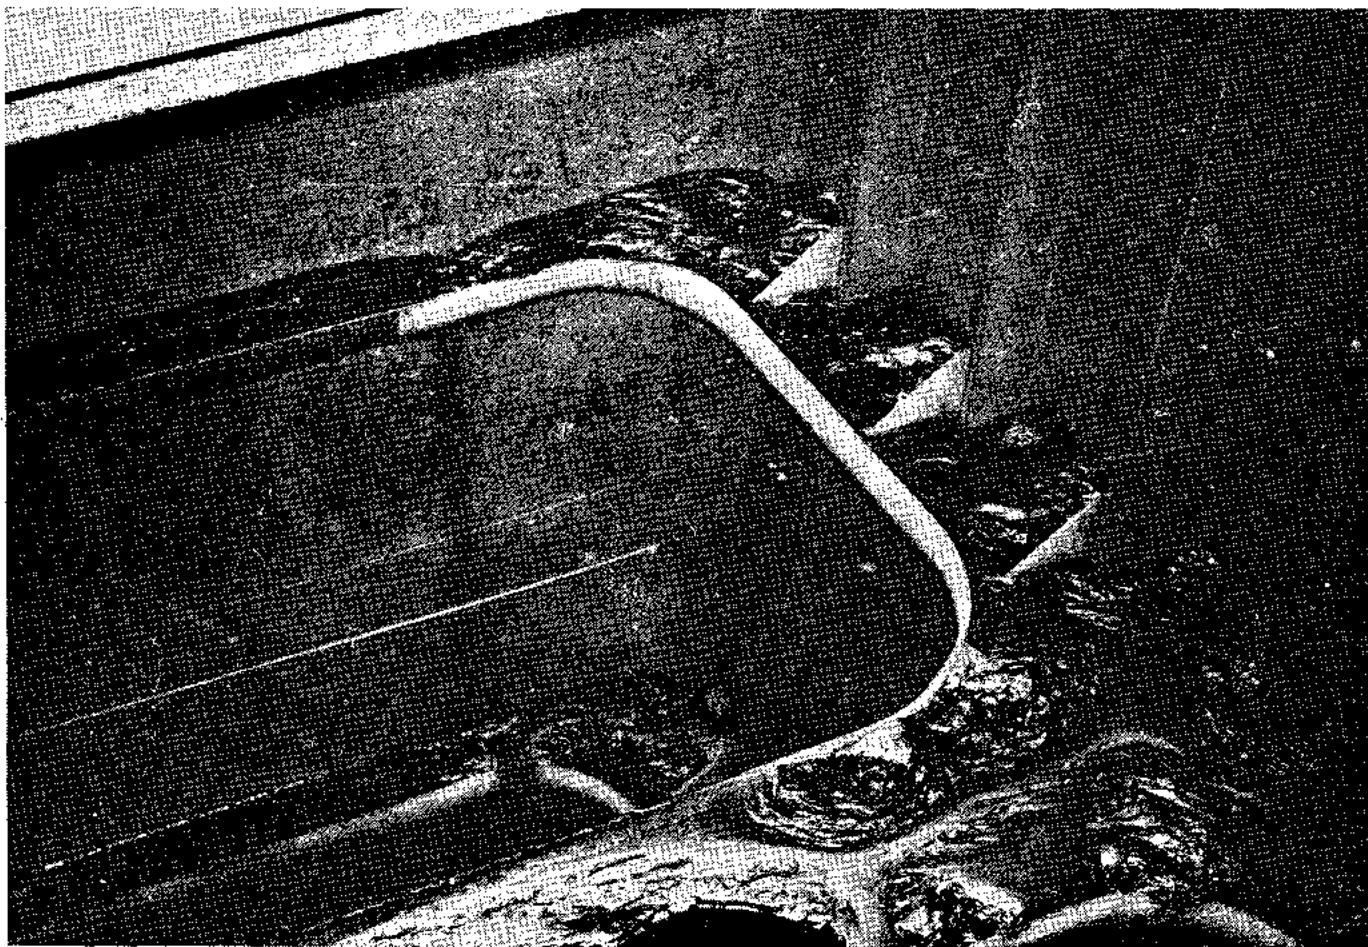
Fig. 8. Accumulation of sludge on horizontal stringers.

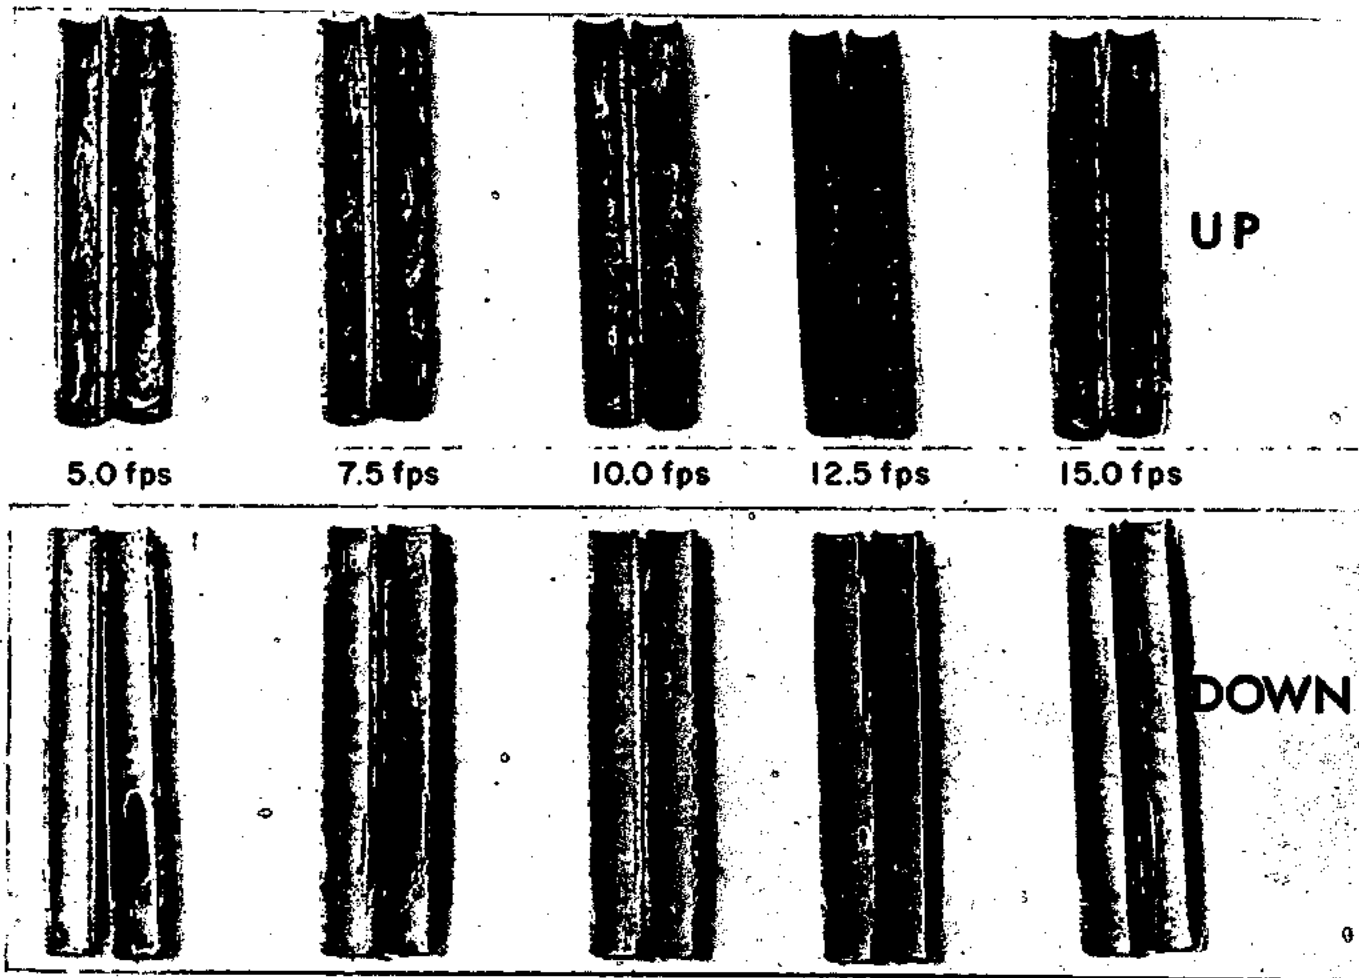
Fig. 12. Comparison of Upstream and Downstream pipe. Films -  
Runs 36-40 - Aluminum Anode (PNL Neg. No. 4265).

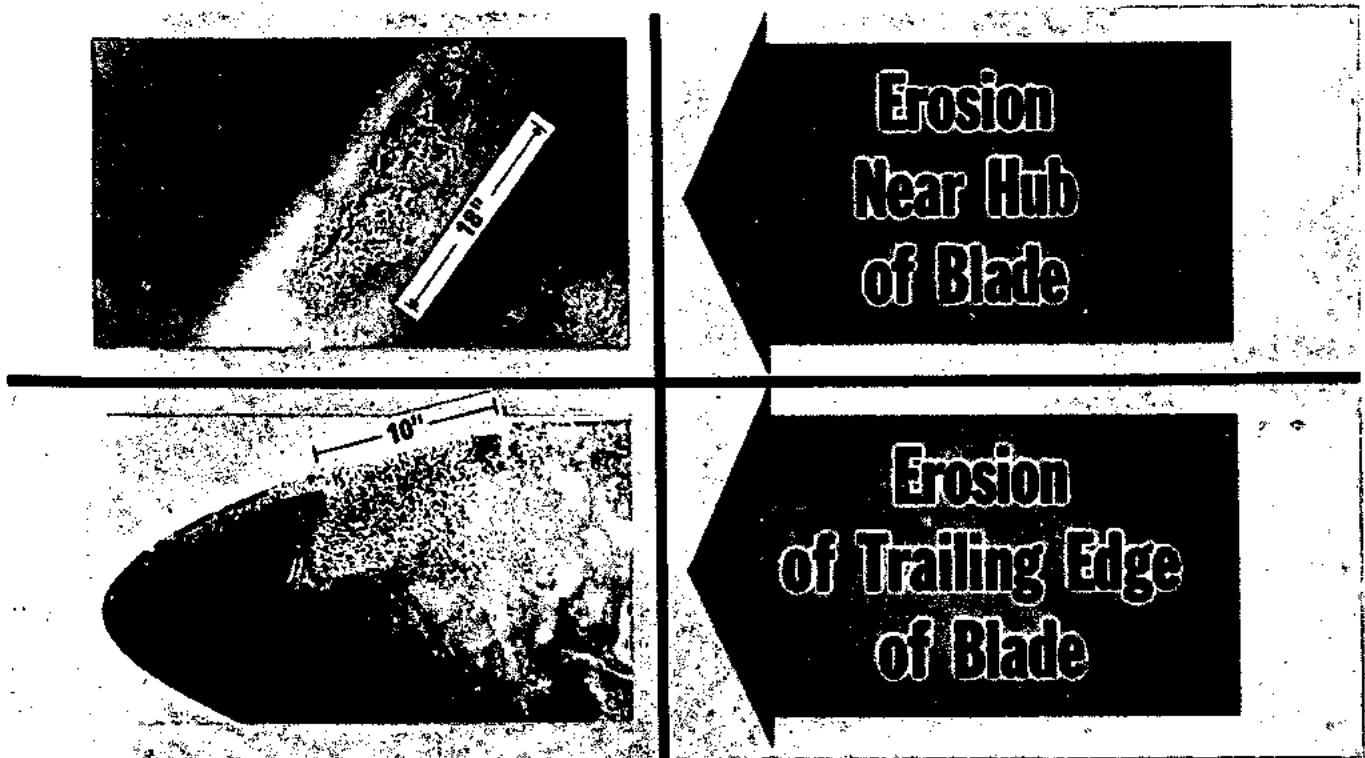
Fig. 1. (Photo No. L 19930-65). Cavitation Erosion of Propeller.

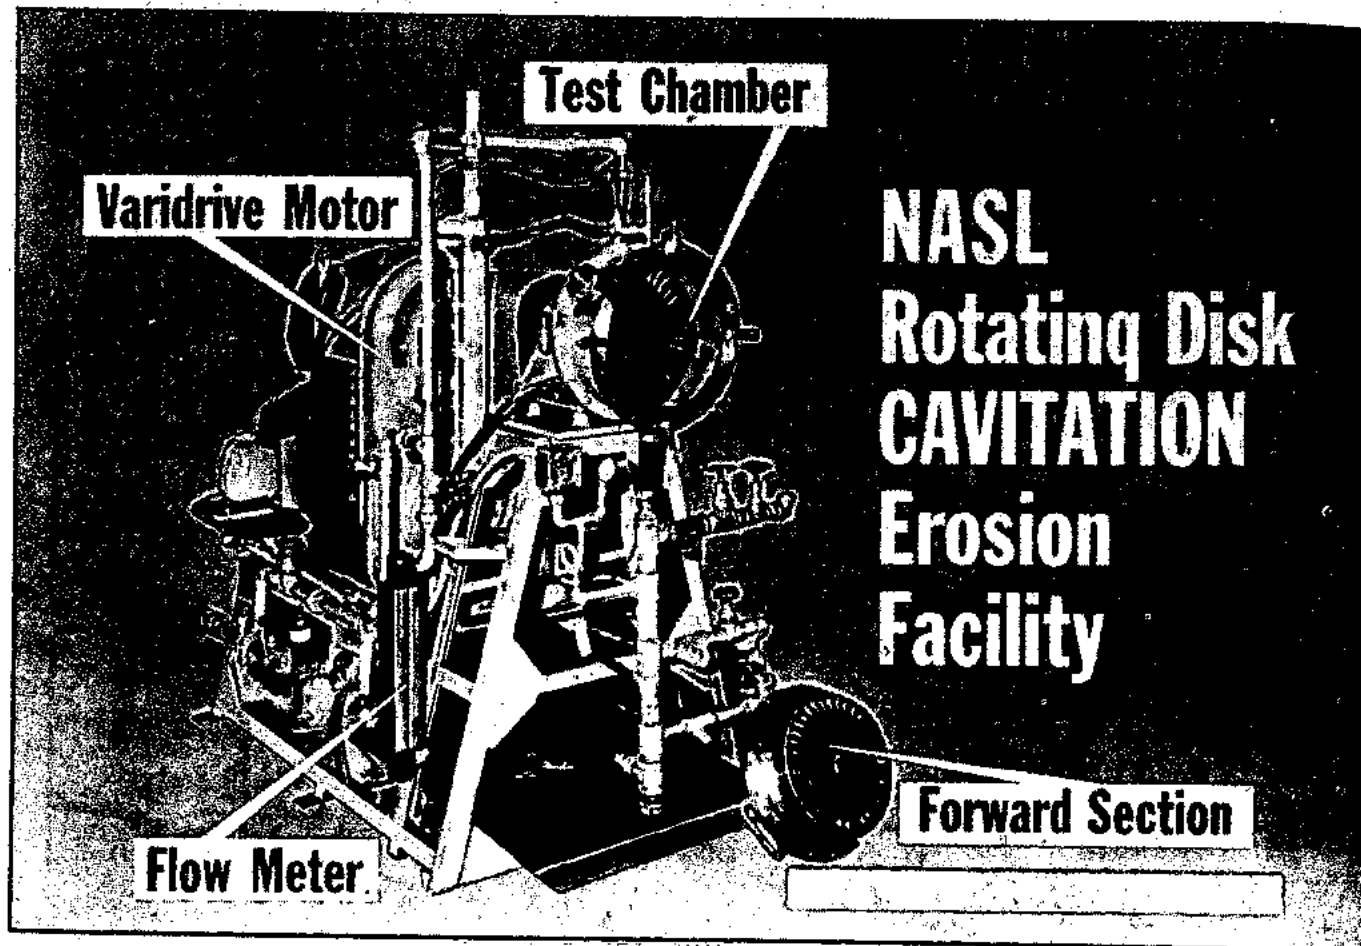
Fig. 6. (Photo No. 19930-70). NASL Rotating Disk Cavitation Erosion Facility.

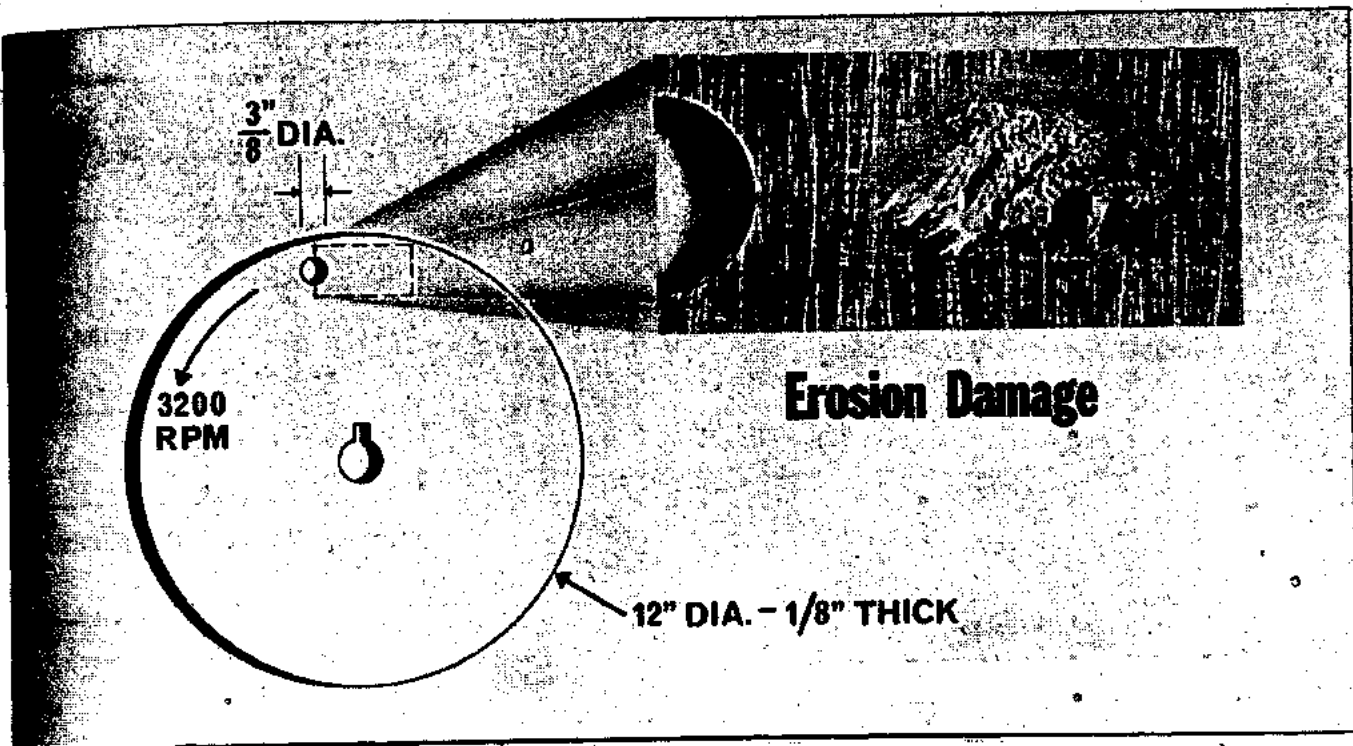
Fig. 7. (Photo No. 19930-69). Typical Erosion Damage of metal in Rotating Disk Apparatus at 150 Ips.

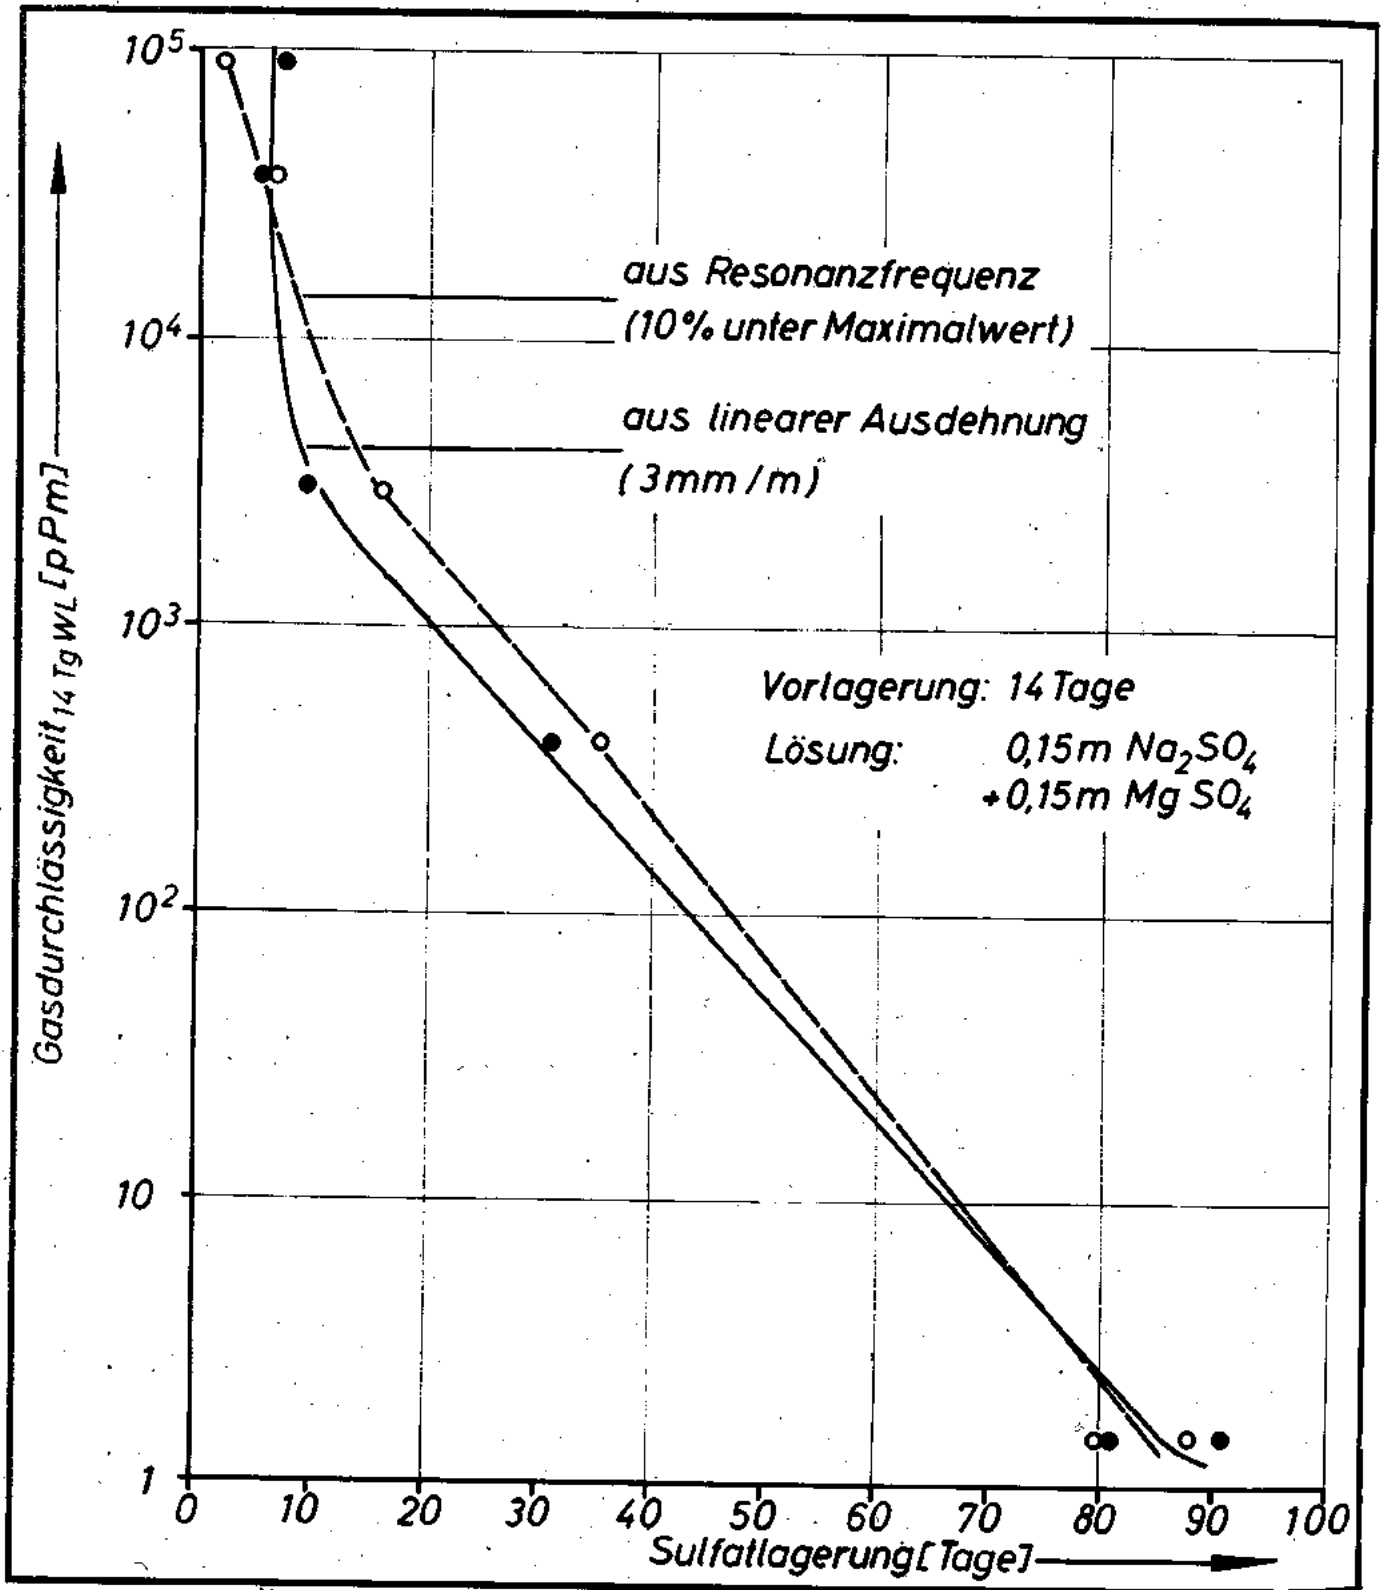
Abb. 2 Aggressivbeständigkeit eines HOZ 375 (40% HOS) in Abhängigkeit von der Gasdurchlässigkeit.
