2<sup>ème</sup> CONGRÈS INTERNATIONAL DE LA CORROSION MARINE ET DES SALISSURES  
2<sup>nd</sup> INTERNATIONAL CONGRESS ON MARINE CORROSION AND FOULING  
2. INTERNATIONALER KONGRESS FÜR MEERWASSERKORROSION UND BEWUCHS  
2<sup>ον</sup> ΔΙΕΘΝΕΣ ΣΥΝΕΔΡΙΟΝ ΘΑΛΑΣΣΙΑΣ ΔΙΑΒΡΩΣΕΩΣ ΚΑΙ ΡΥΠΑΝΣΕΩΣ

20th to 24th September 1968 in Athens (GREECE)

Corrosion and protection of structure immersed in sea water or subjected to marine environments. Cathodic protection. Electrochemistry of sea water.

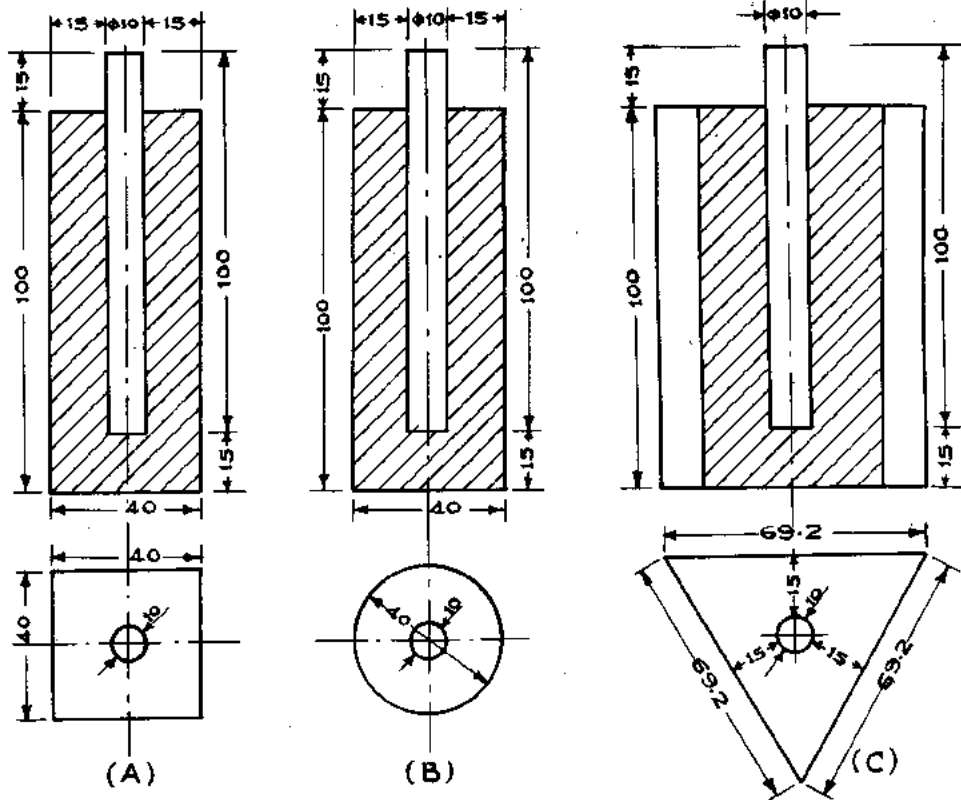
Fig. 1. Différents types d'éprouvettes utilisées.

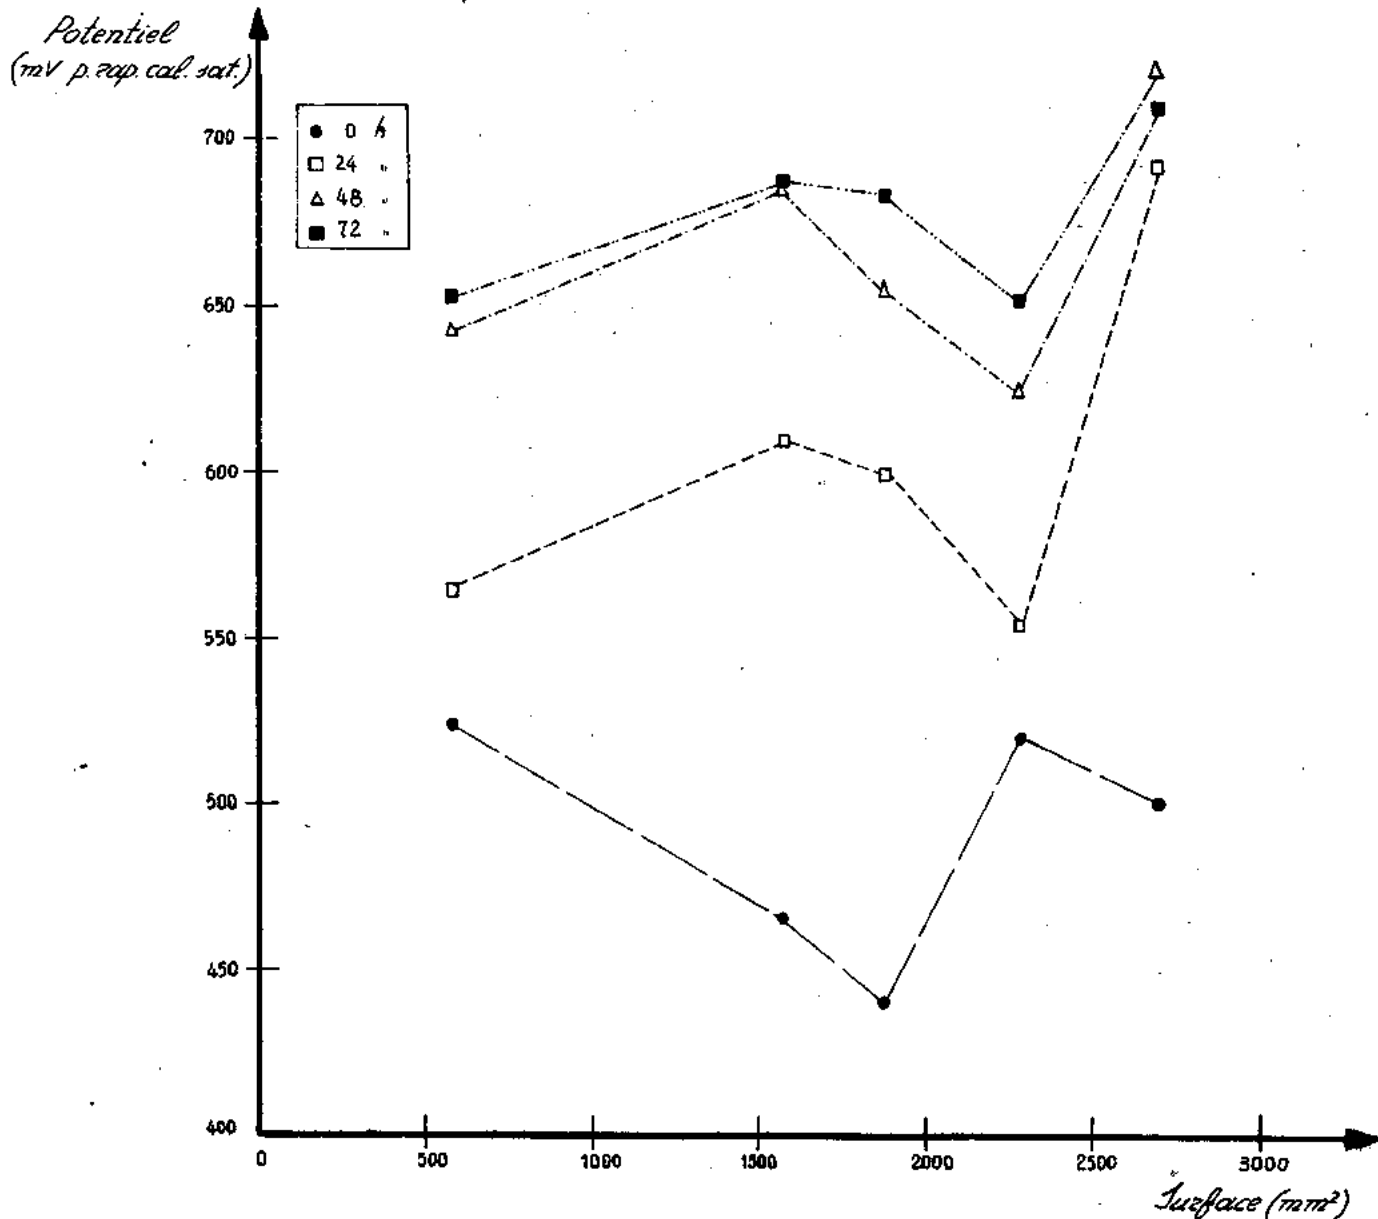
Fig. 6. Potentiel d'acier (p. rap. cal. sat.) par rapport au temps et de la surface immergée.

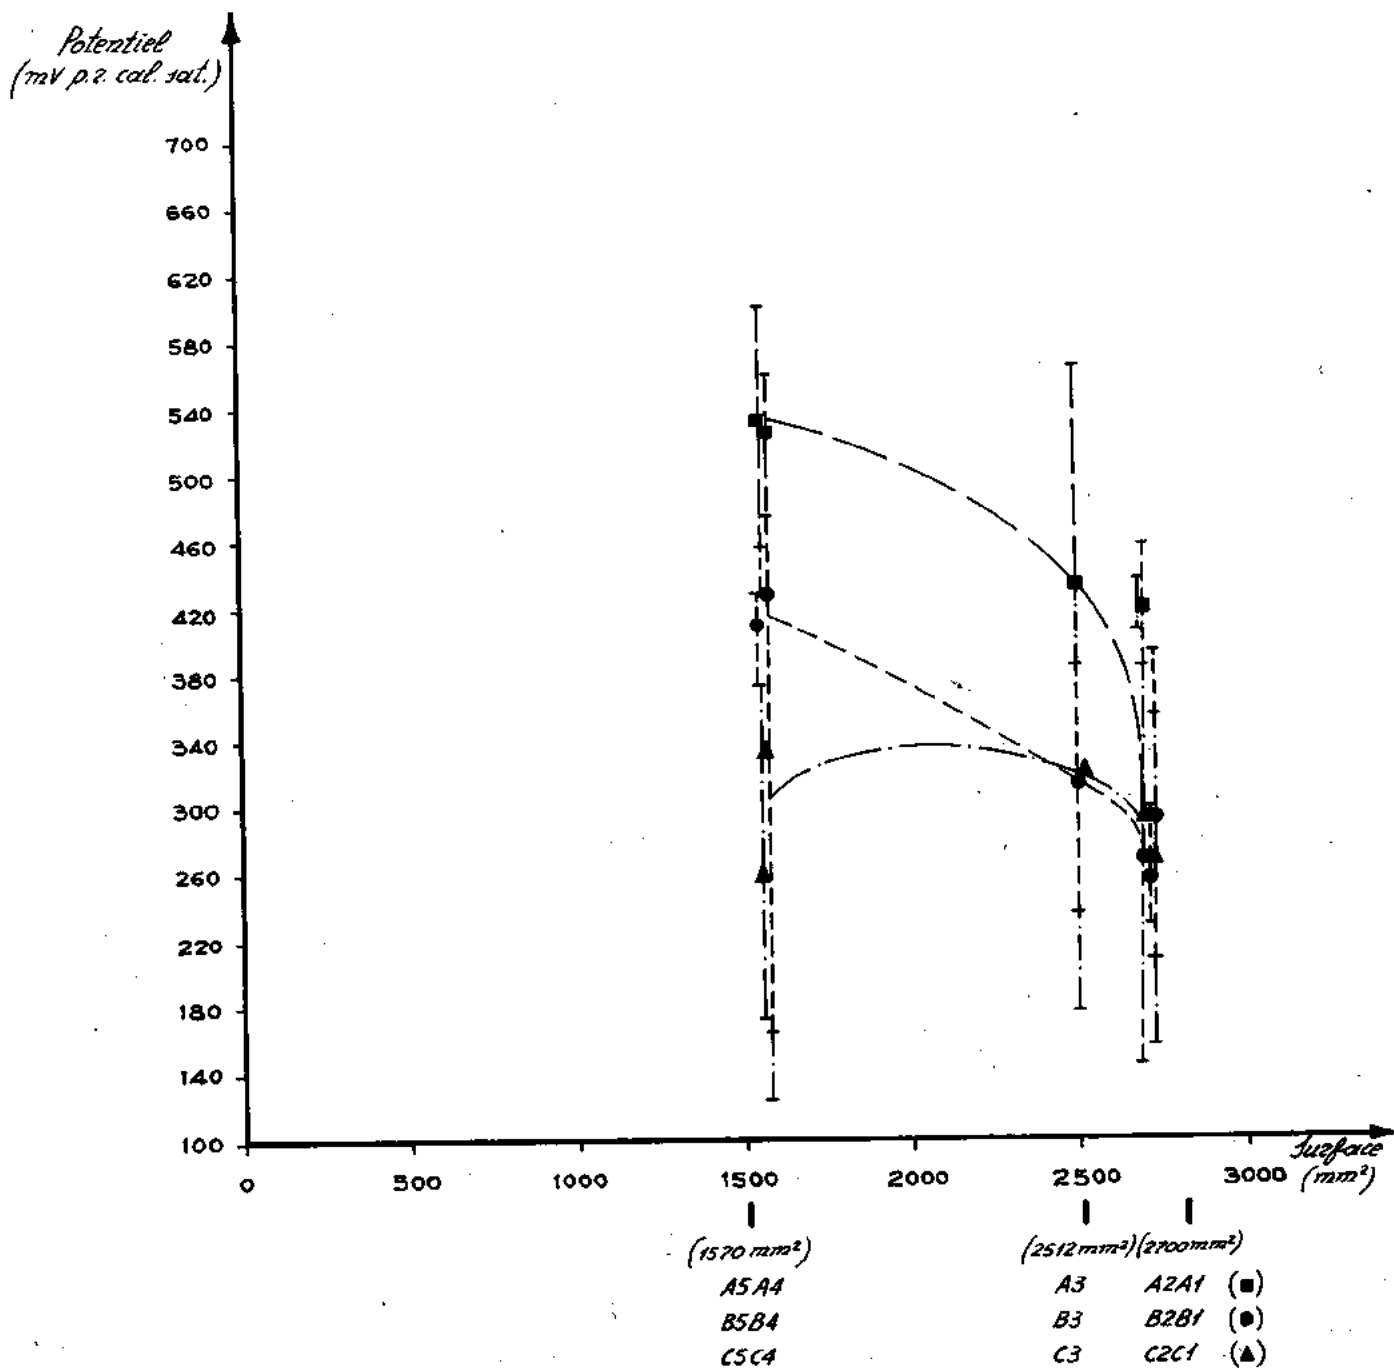
Fig. 7. Potentiels des différents types (A, B, C, Fig. 1) et différentes isolations (1-5 Fig. 2) p. rap. à cal. sat.

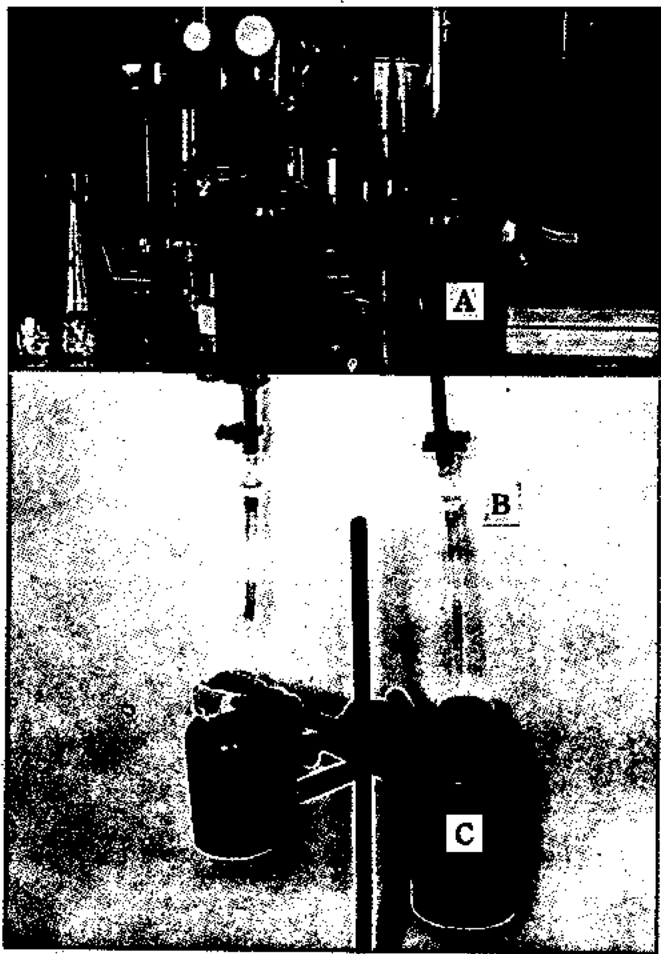
Fig. 1. Two sets of apparatus for checking responses of veliger larvae to experimental chlorinations.  
 A: Diluted chlorine solution vessel.  
 B: Chamber for larvae.  
 C: Vessel for waste.

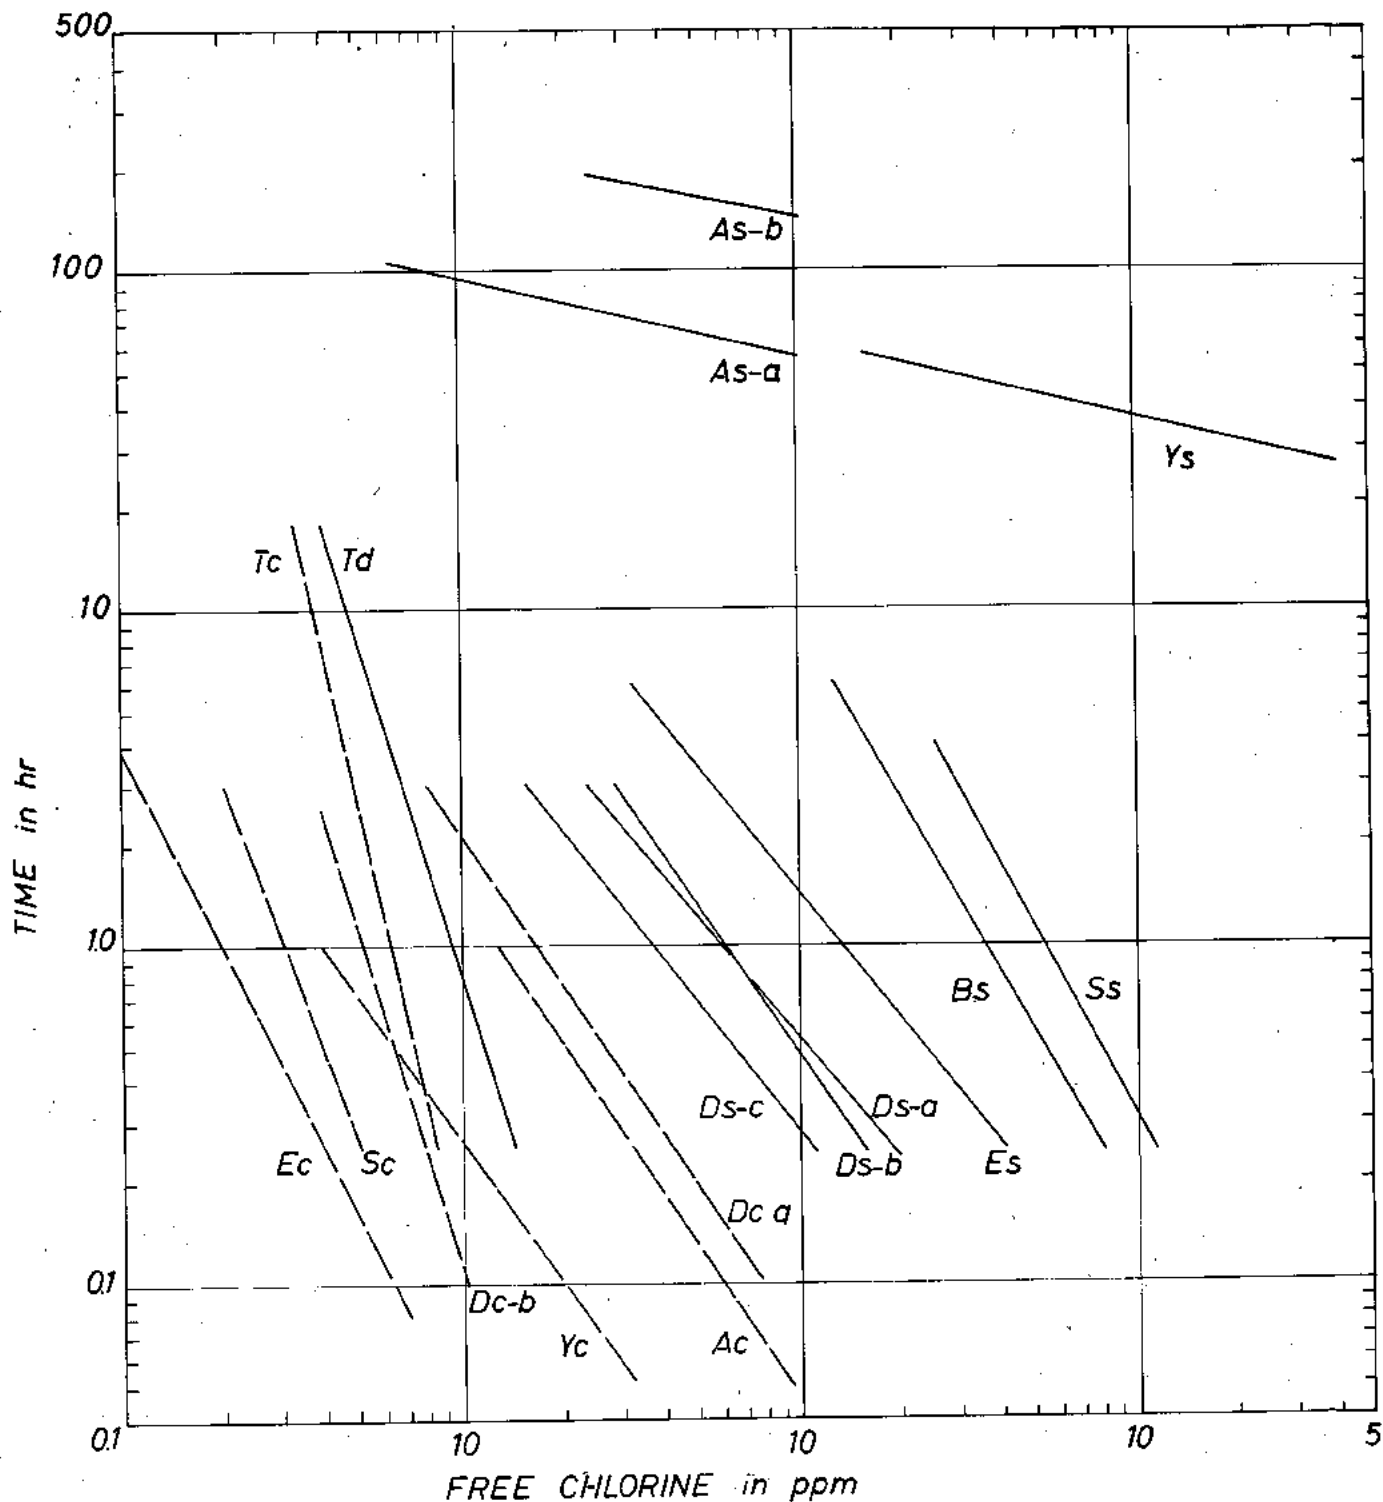
Fig. 8. The responses of *Mytilus edulis* in each stage to free chlorine, as shown by relation between free available chlorine and contact time.  
 Solid lines indicate 50% survival. Dotted lines indicate 50% shell Hyphen closing.

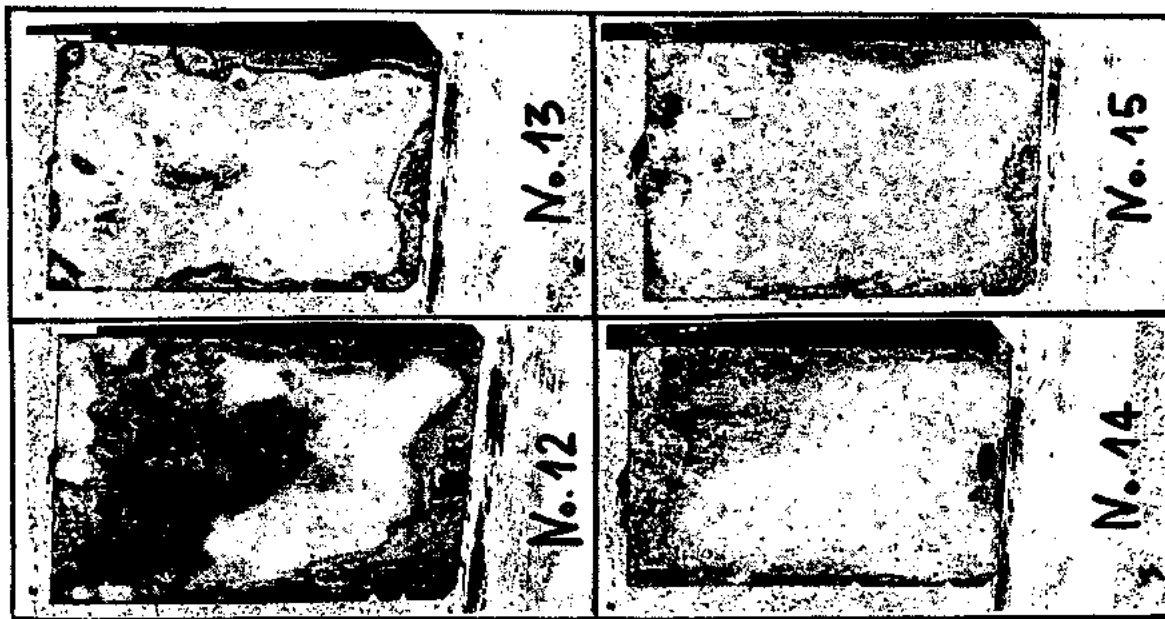
Fig. 5. Peintures vinyliques à haute teneur en résine, après 10 mois d'immersion.

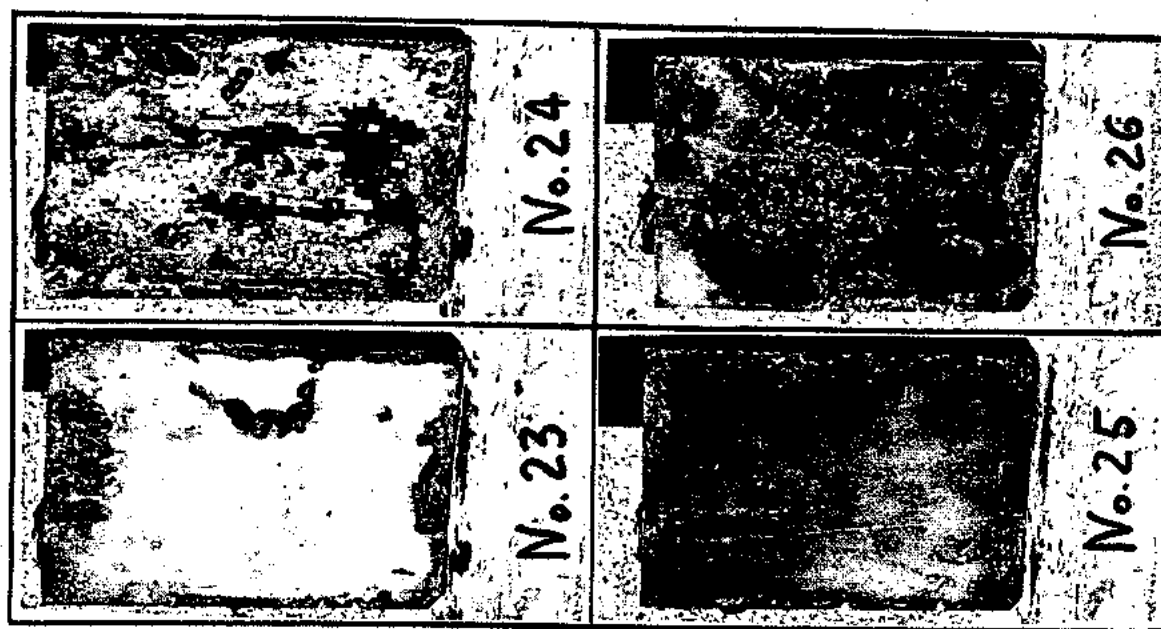
Fig. 7. Peintures époxy-résineuses, après 10 mois d'immersion.  
 No. 23 : Peinture renforcement du  $Cu_2O + TPPLLA$   
 No. 24 : " " " " " "  
 No. 25 : " " " " " "  
 No. 26 : " " " " " "

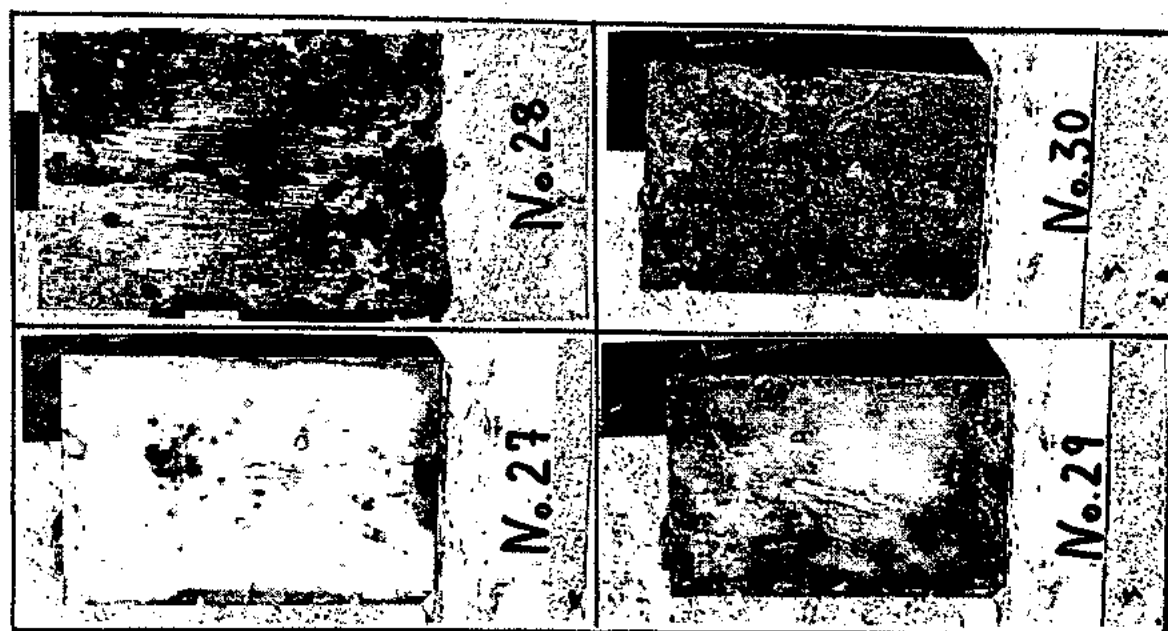
Fig. 8. Peintures époxy-résineuses, après 10 mois d'immersion, excepté l'éprouvette No. 28, qui a été immergée pendant 4 mois et défil.  
 No. 27 : Peinture renforcement du  $TPLLA$   
 No. 28 : " " " " sans  $Cu_2O$   
 No. 29 : " " " " "  
 No. 30 : " " " " "

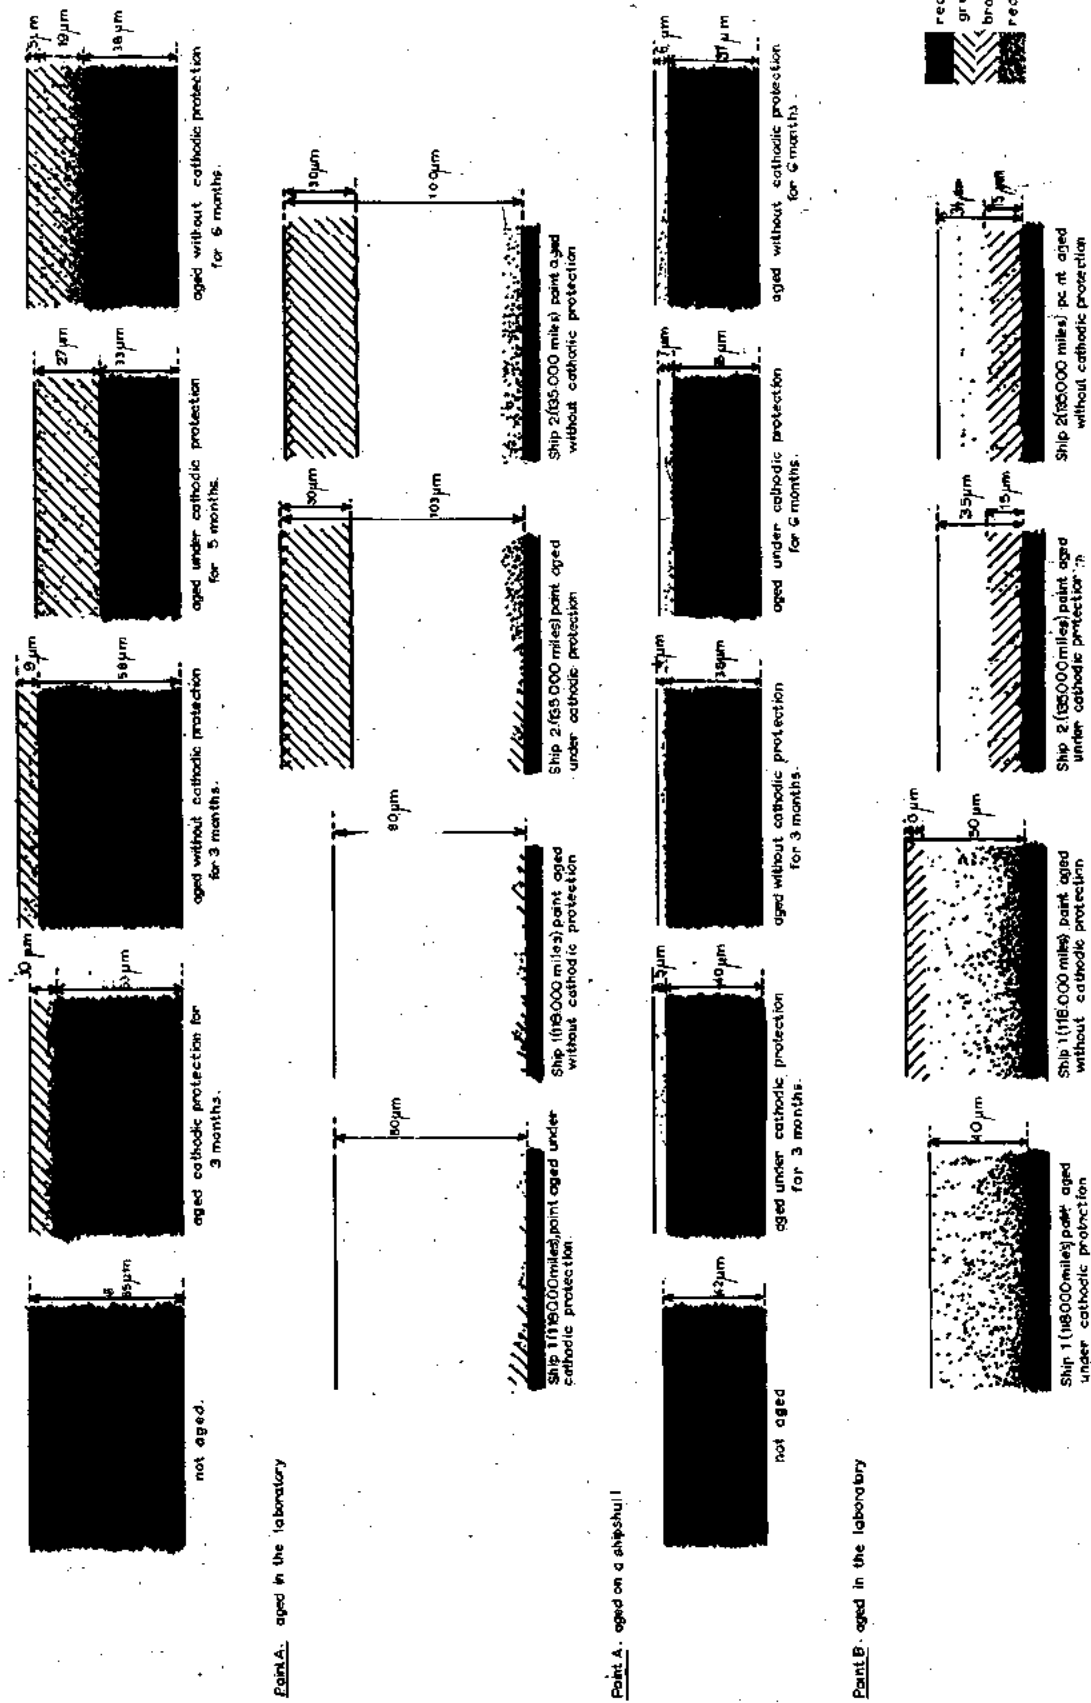
Fig. 4. Schematic picture of the cross-sections of the paint A and B.

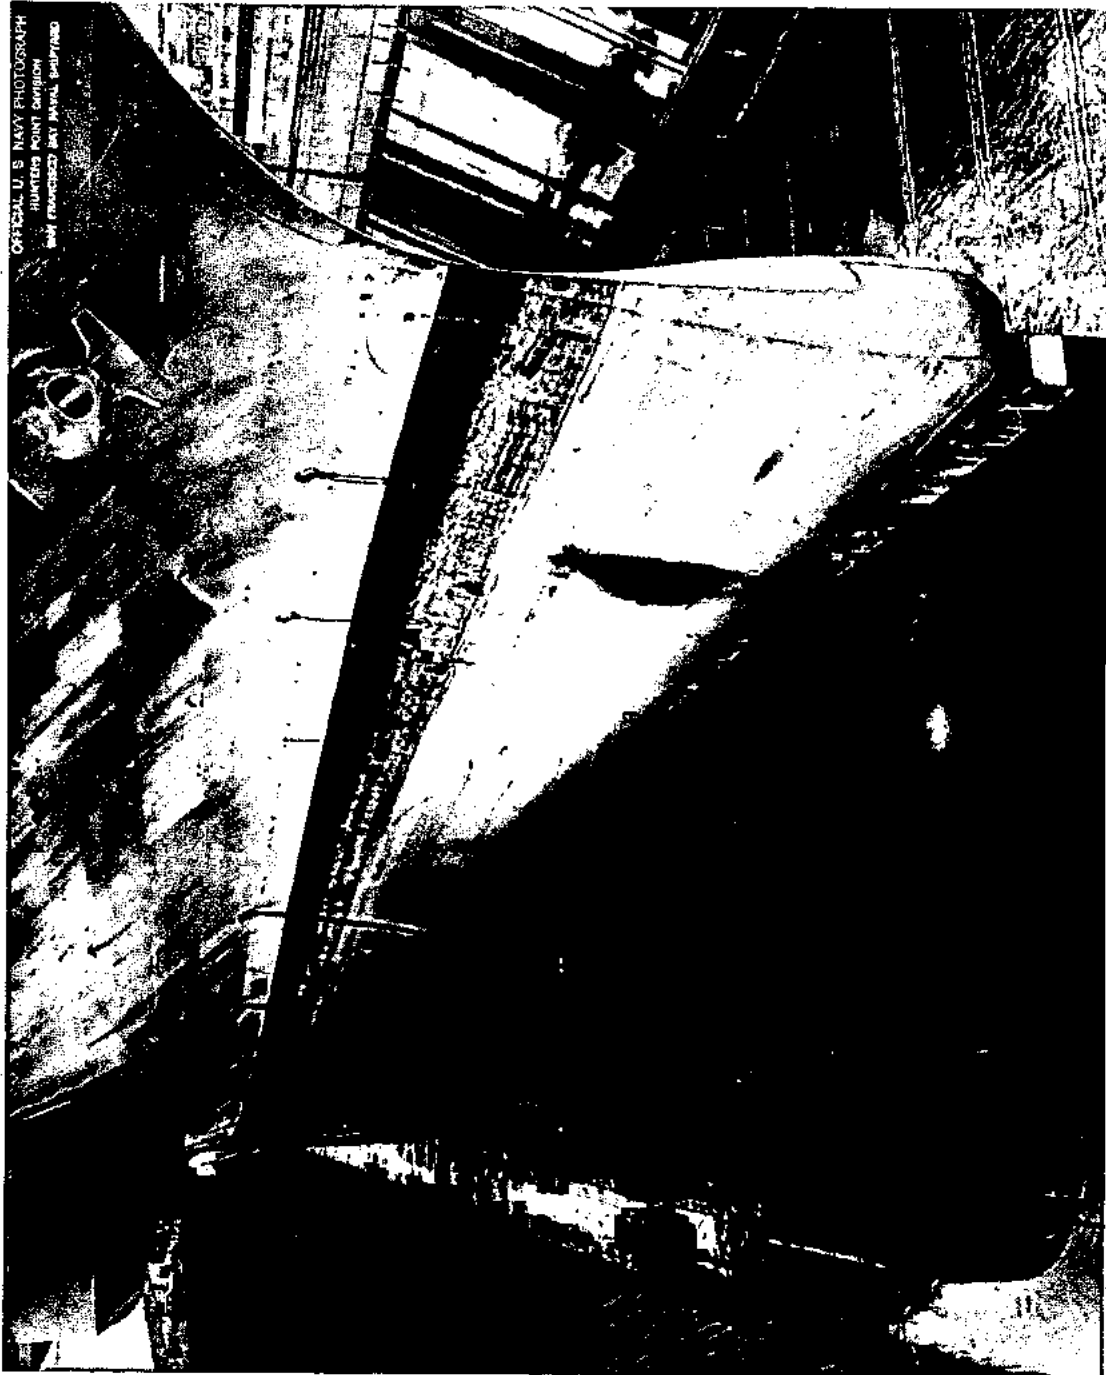
Fig. 3. Three years performance of hot plastic anti-fouling coating on a carrier.

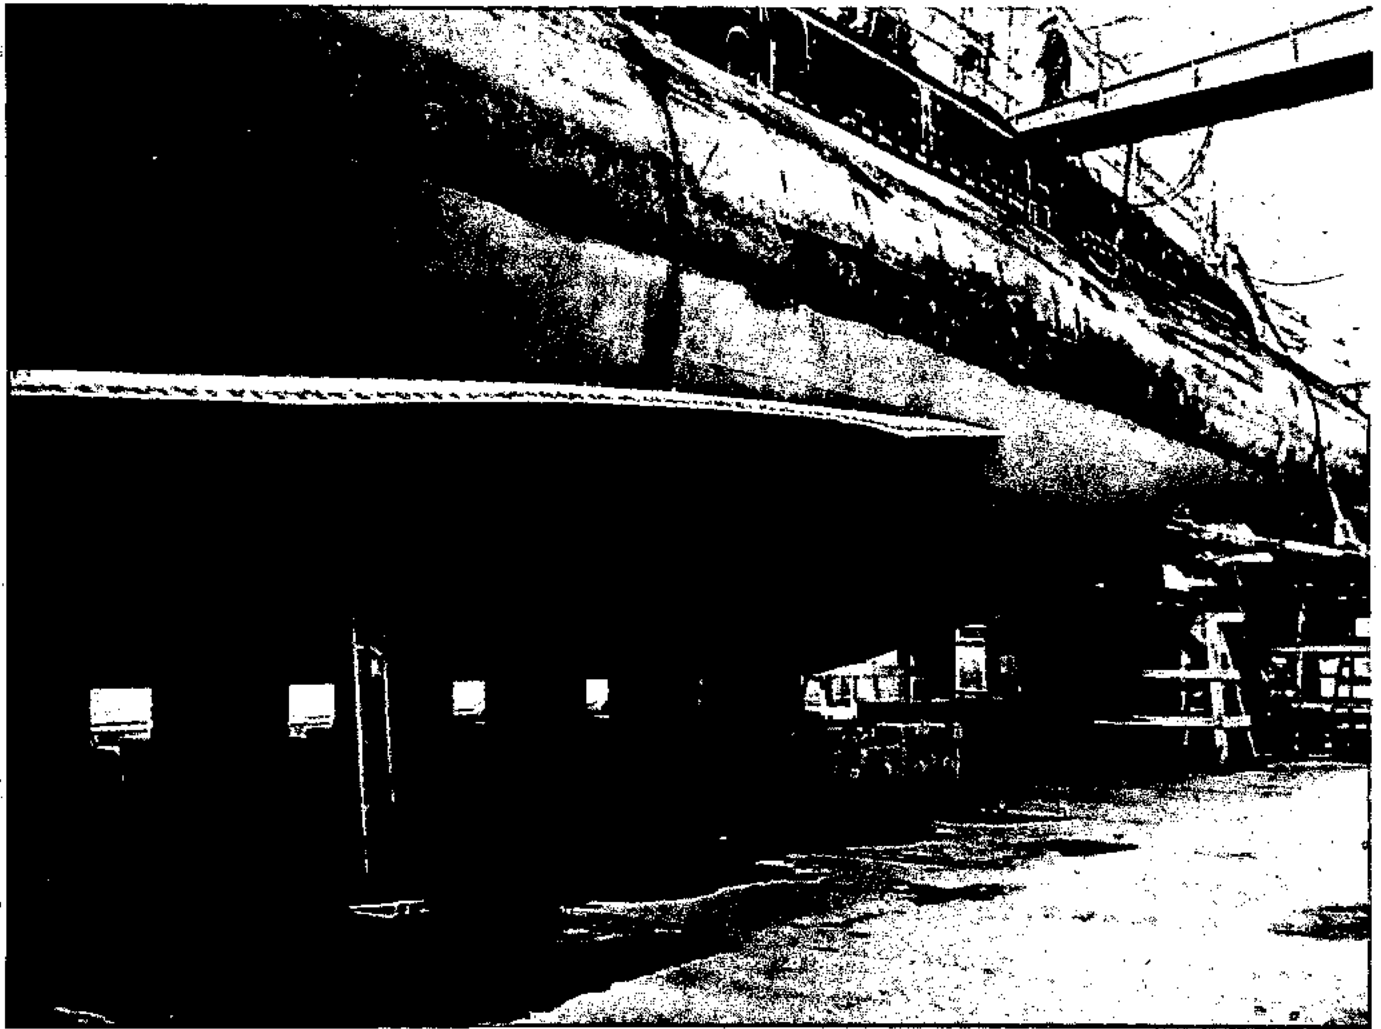
Fig. 5. Eight months performance of vinyl shipbottom paint system (i-117, 4-119 and 2 coats 121) on a submarine.)
